PERMAFROST  
TECHNOLOGY  
FOUNDATION

FOUNDATION STABILITY  
RESEARCH

1664 KIVALINA STREET  
FAIRBANKS ALASKA

JUNE 1998

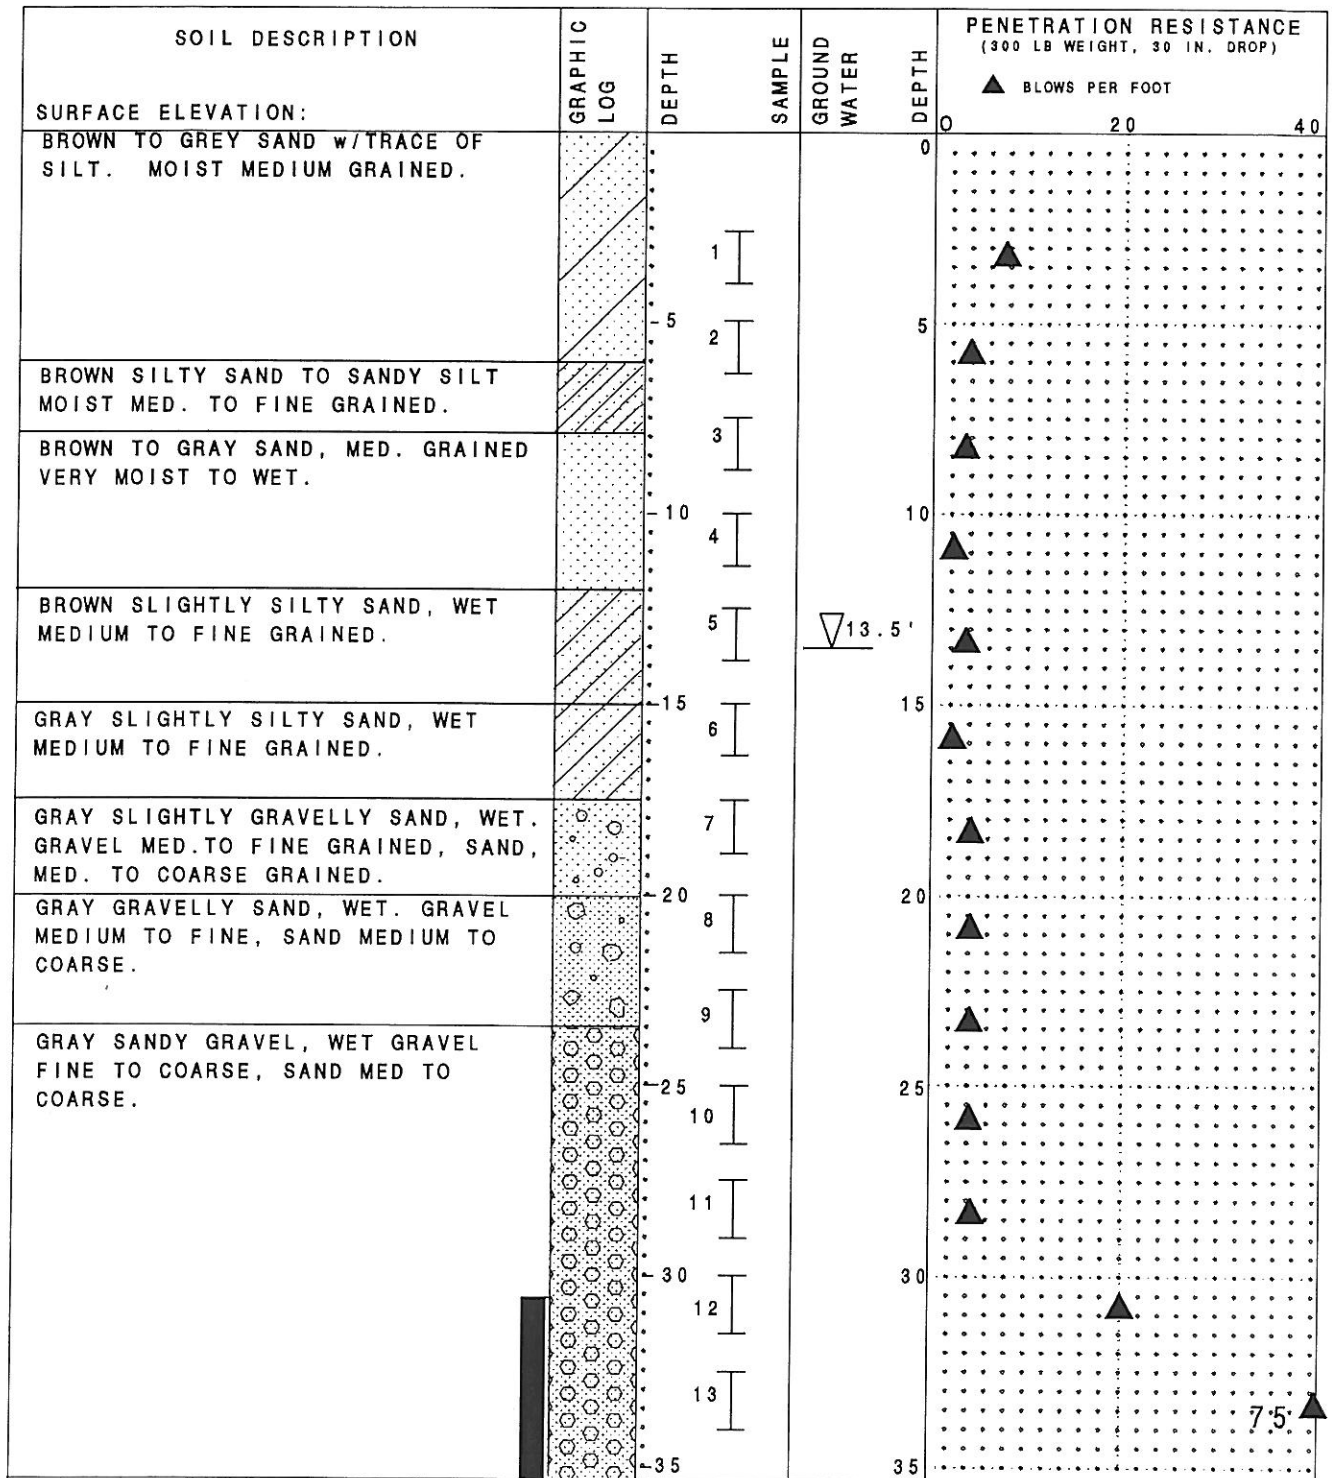
NAME: 1664 KIVALINA ST.  
 LOCATION: BH1 N.E. CORNER  
 PAGE: 1 OF 2  
 DATE: JULY 23, 1992

The Geotechnical drilling consisted of one boring located at the north side of the structure. This boring was drilled on July 23, 1992 and near the location of a previous soils boring logged by our office on October 27, 1988. The soils data obtained by the P.T.F. indicates the presence of permafrost at a depth of 30.5 feet below the ground surface.

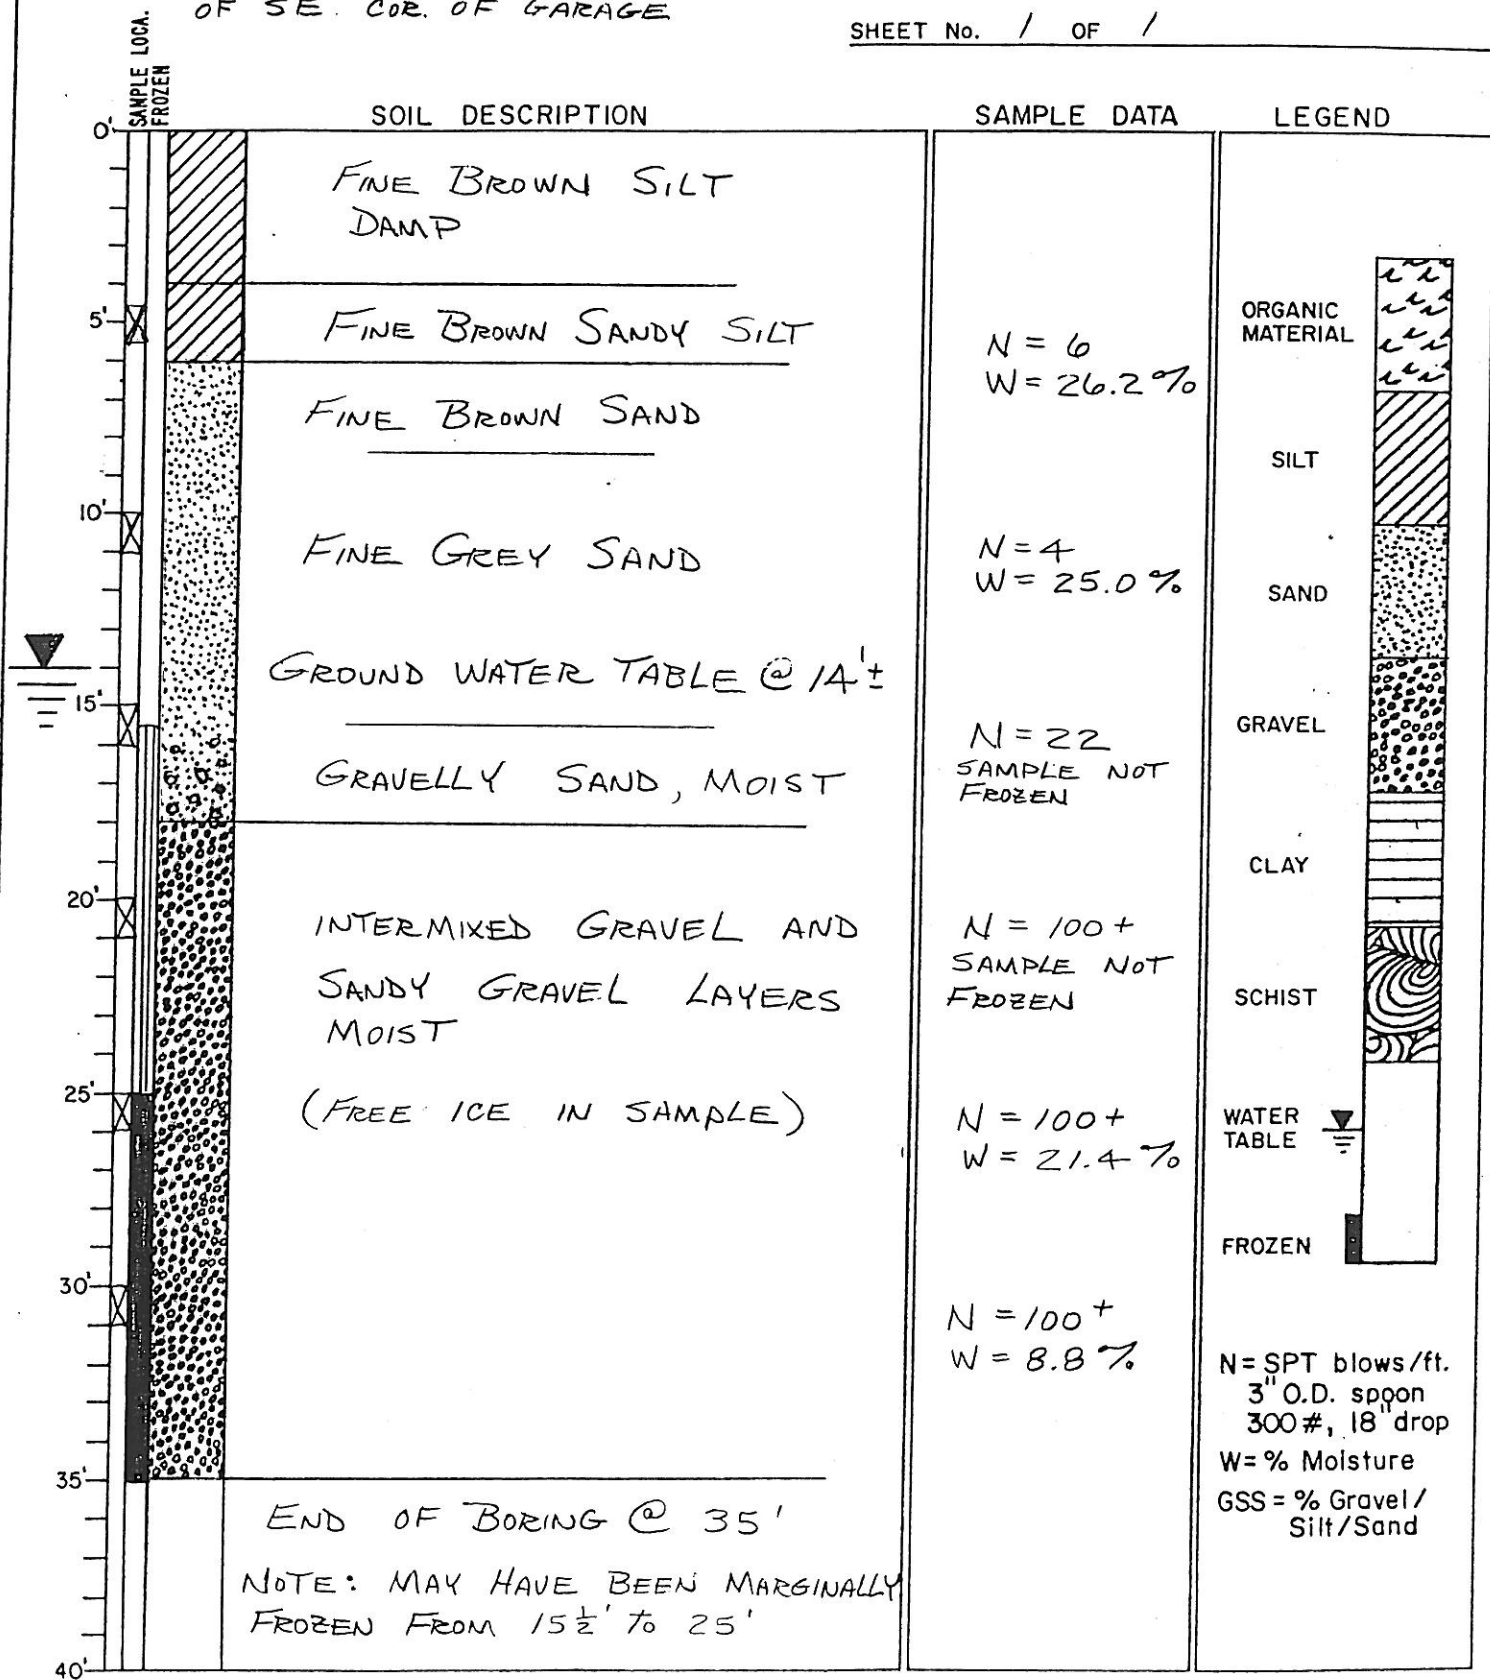
Permafrost was encountered in both TH #1 and 2 at depths of 25 and 23 feet respectively. Marginally frozen ground was encountered in TH #1 from a depth of 15½ to 25 feet. This did not contain excess moisture. Excess moisture in the form of ice crystals was found in both test holes, as indicated on the soil logs. Fairly loose sand was encountered in both test holes from a depth of approximately five feet down to frozen soils. This is indicated by N values of 10 or less on the soil logs.
