PERMAFROST
TECHNOLOGY
FOUNDATION

FINAL REPORT

FOUNDATION STABILITY
RESEARCH

19 - 21 GLACIER AVENUE
FAIRBANKS, ALASKA

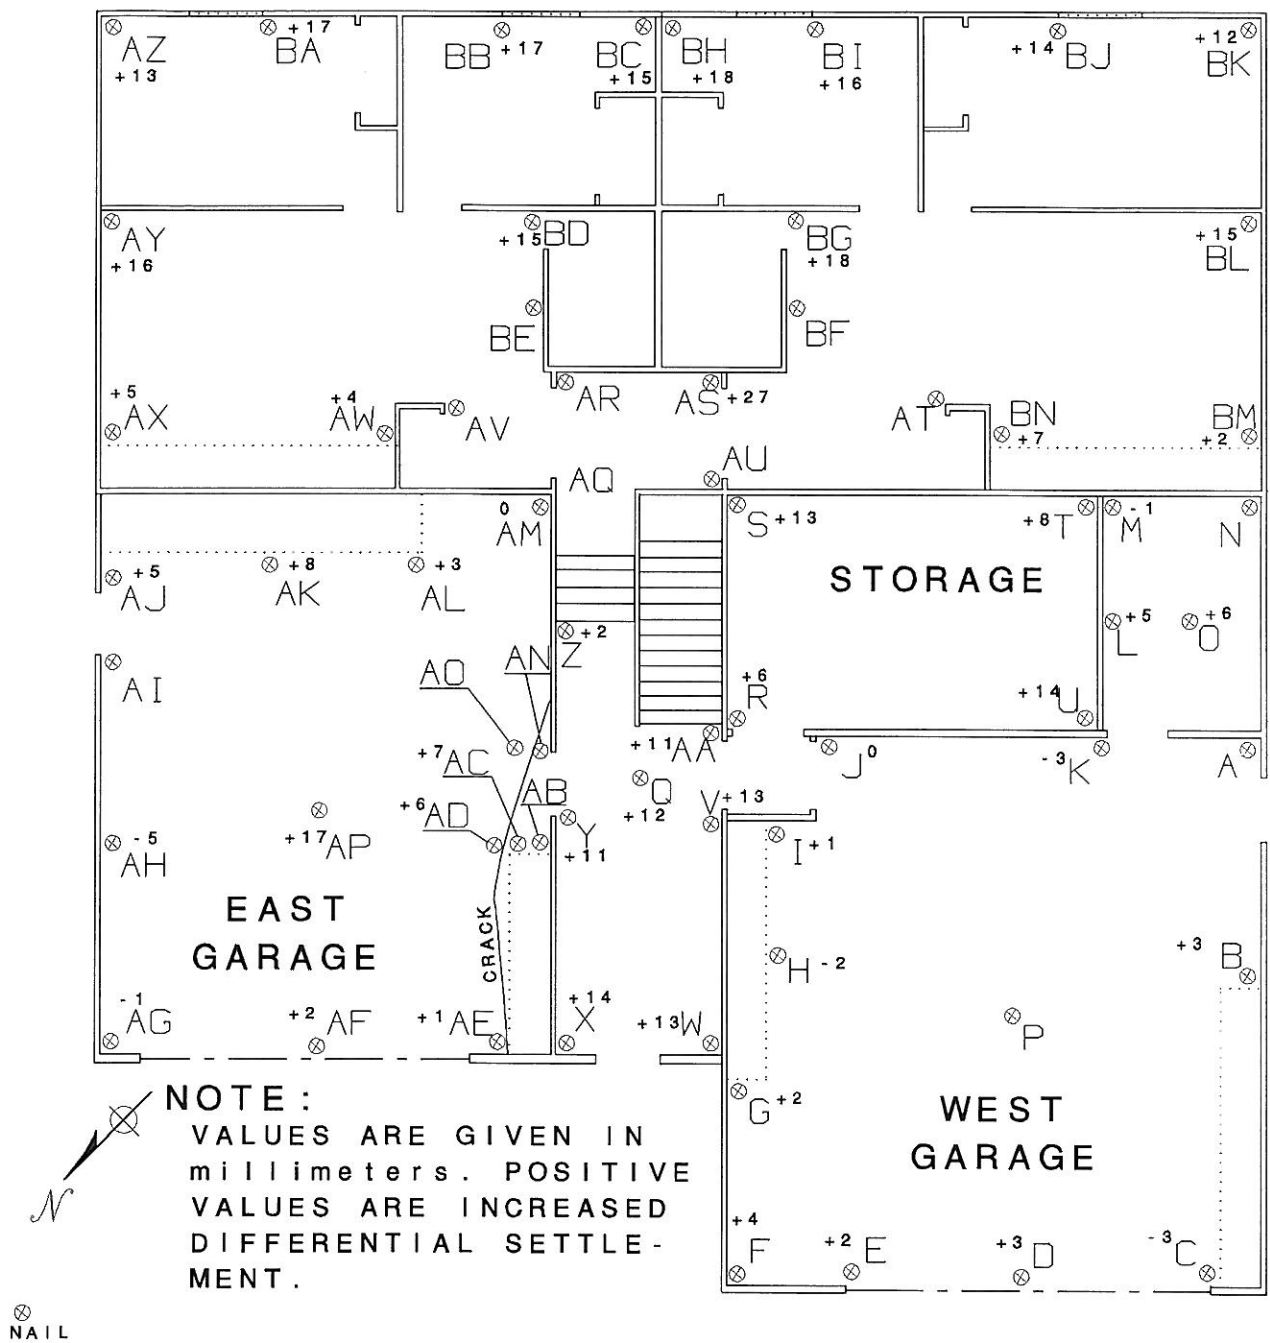
FIGURE 3 Differential settlement changes at each measurement point during the six years of record.

The data on the levels and the crack width monitoring, however, did provide a good deal of information on the stability of the structure as it now stands. Figure 3 shows the increase of differential settlement in millimeters at each measuring point on the lower level of the structure for the period over which measurements were made. In the six years of record, the differential settlement of the concrete floor in the lower level (i.e. the daylight basement apartments and the garages) increased at nearly every point of measurement. The increase was not great. The maximum increase was 27 mm (1-1/8 in.), which indicates that the building is still moving since all but two points (J and AM) showed a change in the differential. The elevation vs. time plots (see appendix) indicate that this is a uniform gradual increase rather than an abrupt increase as might be brought on by a one-time dynamic event such as an earthquake.

Since the differential increase is generally positive, with respect to point A, it suggests that either point A is settling more rapidly than all other points, or that the other points are actually rising (heaving) with respect to point A. Since the structure has been heated for the entire period, it seems unlikely that frost heaving has taken place beneath the house to progressively raise the structure. Individual points in the structure such as the corners of the garage may have frost develop beneath them, but points well inside the structure are

very unlikely to be experiencing frost heaving. It is obvious in Figure 3 that the maximum rise with respect to A occurs along a ridge through the center of the structure from the front entrance to the back wall of the basement apartments. This is not indicative of frost heaving.

This leaves us with the implication that point A has subsided more than the other measurement points. If this is the case, then the settlement has been predominantly along the northwest and north wall of the west garage. With similar settlement along the north and east sides of the east garage. The settlement is small and gradual, amounting to approximately an average of 18 mm (3/4 in.) over a six year period. If this rate continues, some compensation in the foundation will probably have to be made sometime in the next 10 to 12 years. This could be as minor as jacking and filling under the footings along the north one half of the structure to as major as a complete releveling of the entire structure and repairing of the cracked floor slab, footings, and foundation wall.

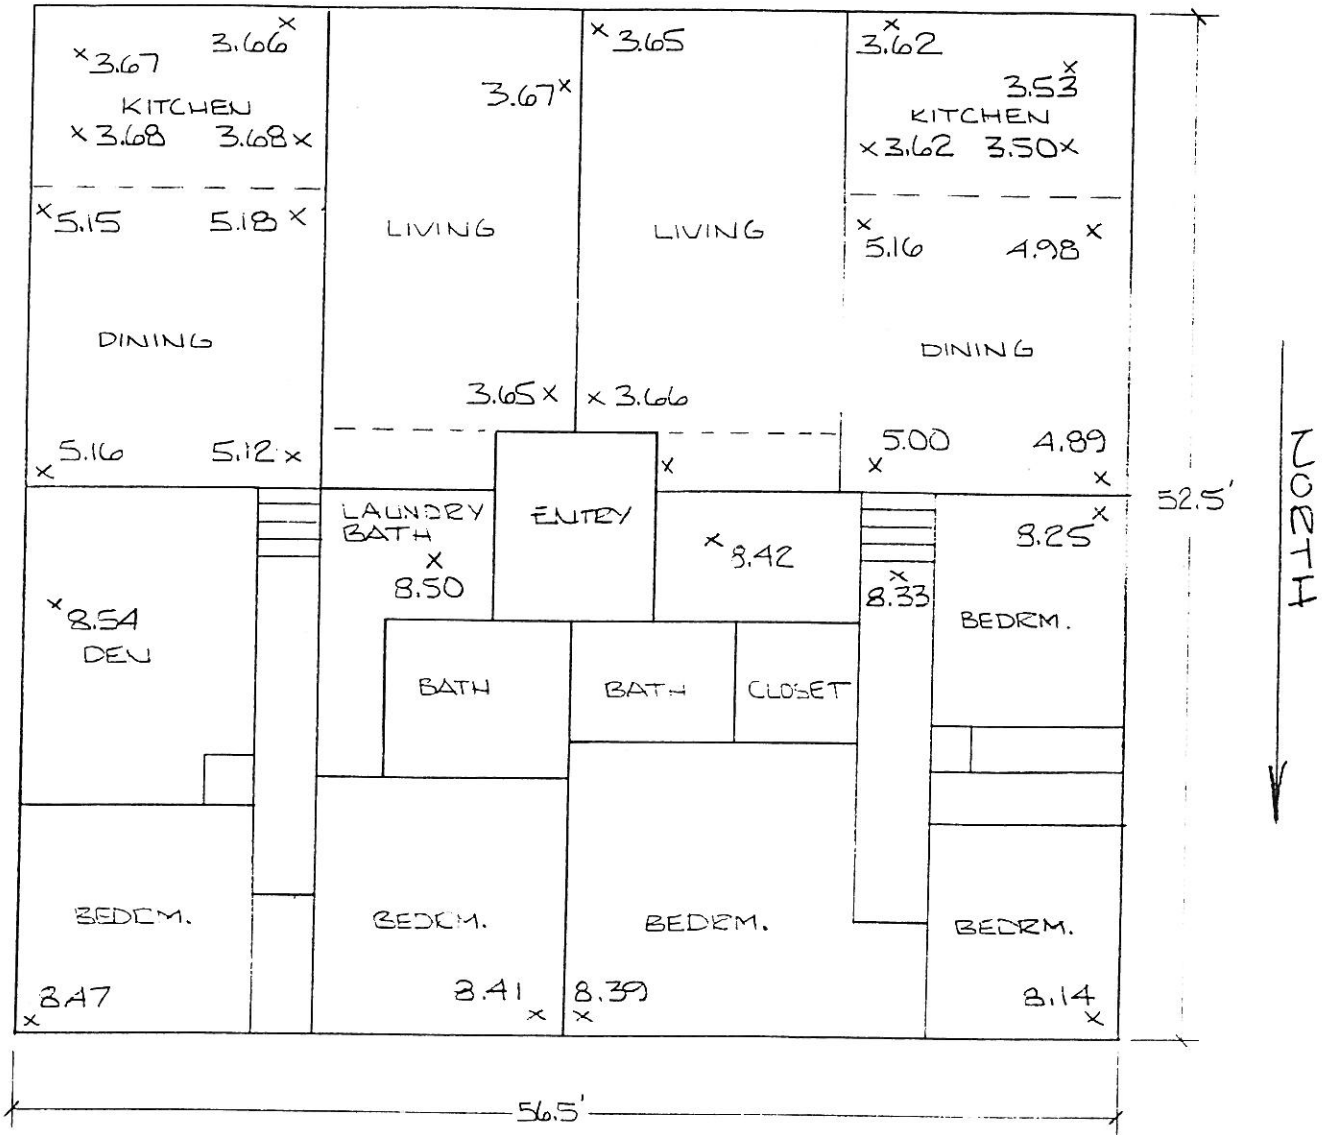
AHFC #49739 19 GLACIER FIGURE 2

Because it was difficult to determine the nature of the movement, we measured relative floor elevations. Figures 1 and 2 indicate that, in general, the Westerly side of the building has settled as much as four or five inches relative to the Easterly side. This is based on the elevations found and the assumption that the building was initially constructed level.

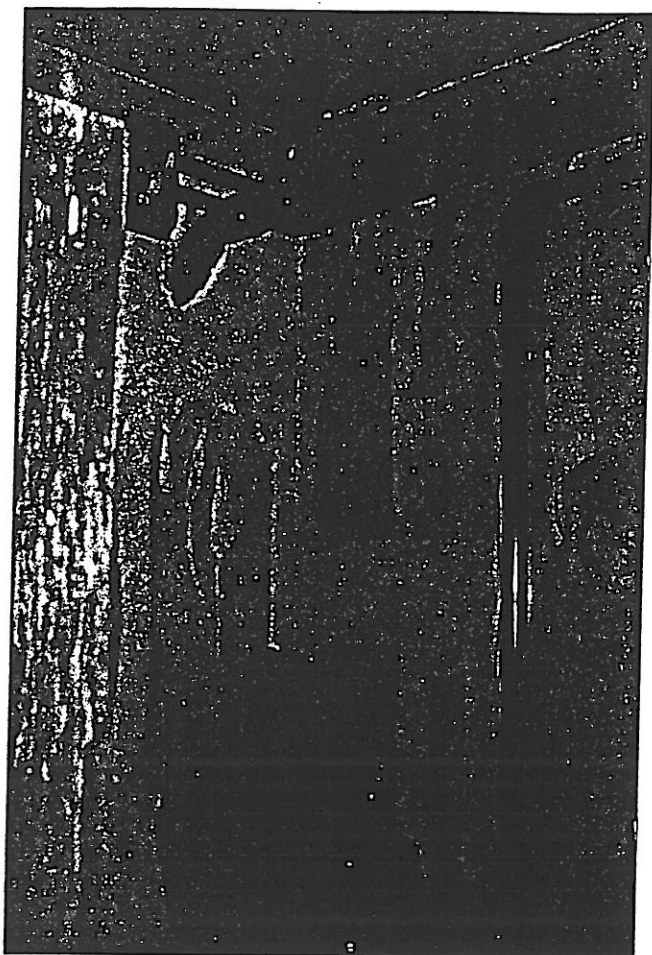
PHOTO #7: SHEARING DRYWALL TAPE IN
SOUTHWEST CORNER OF EASTERLY GARAGE.

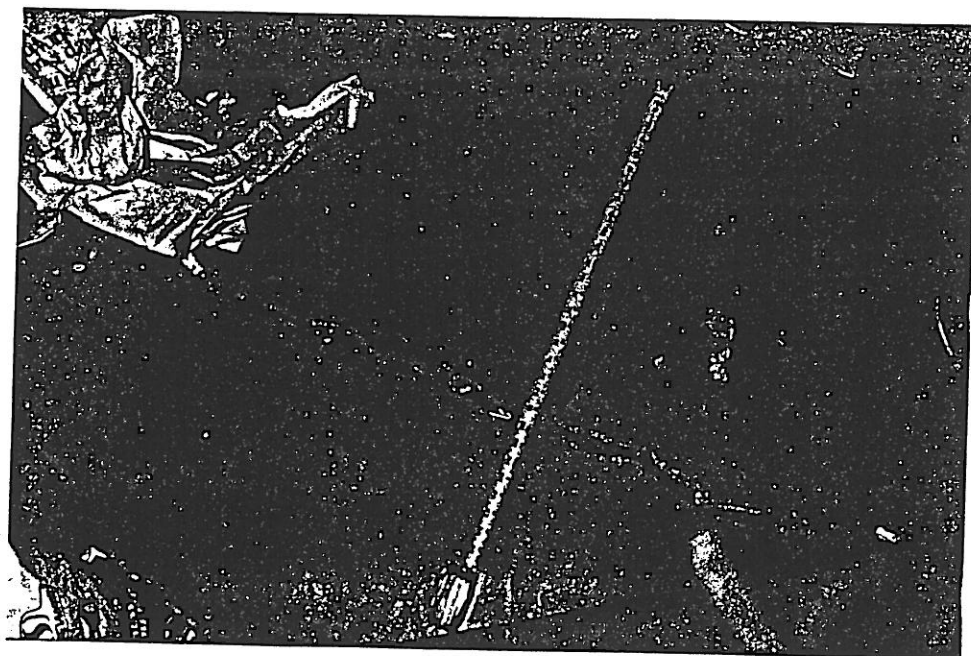
PHOTO #8: WIDE CRACK IN EASTERLY GARAGE FLOOR.

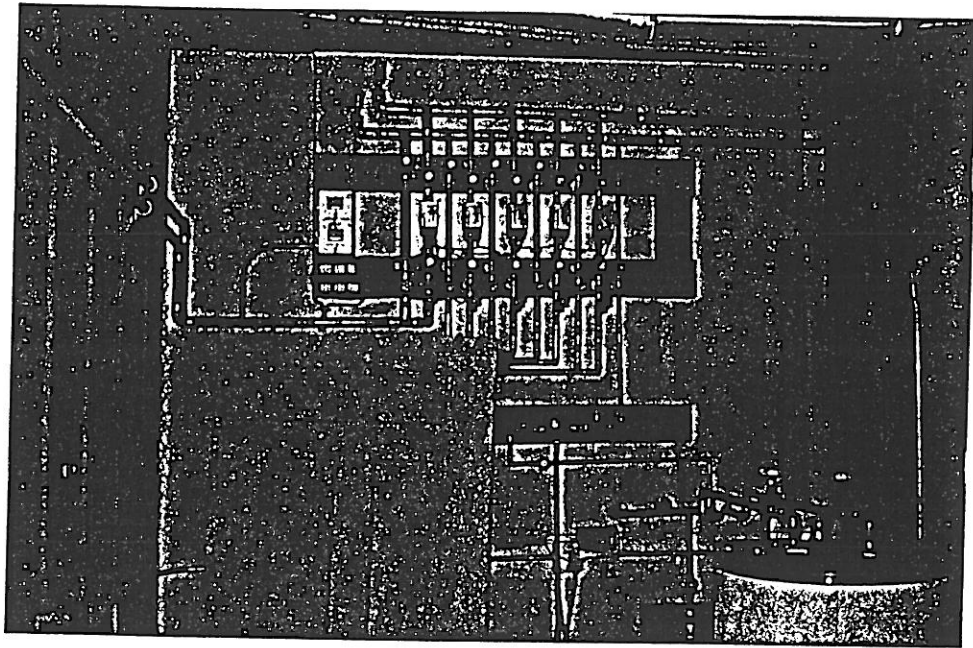
PHOTO #5: SOUTH WALL OF FURNACE ROOM. NOTE THE SHEARING DRYWALL TAPE IN BOTH CORNERS.

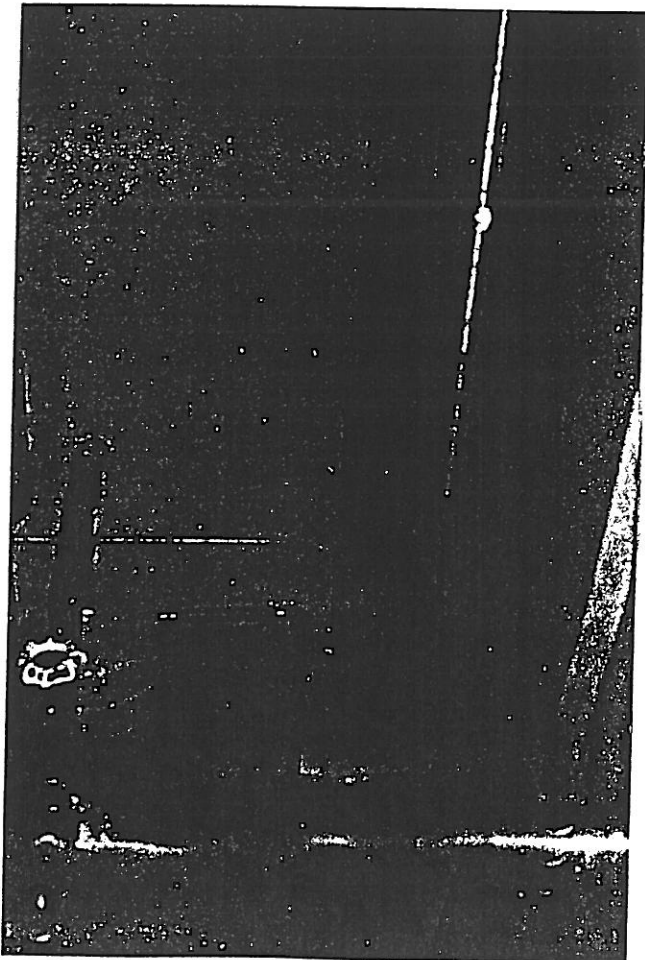
PHOTO #6: SHEARING DRYWALL TAPE IN SOUTHWEST CORNER OF FURNACE ROOM.

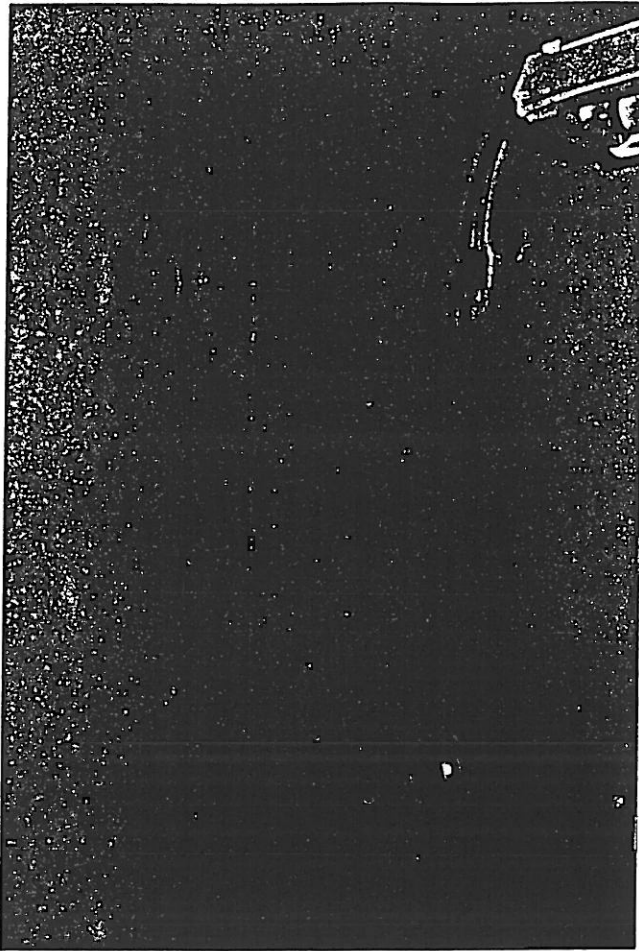
PHOTO #3: SHEARING DRYWALL TAPE
IN SOUTHWEST CORNER OF STORAGE
ROOM.

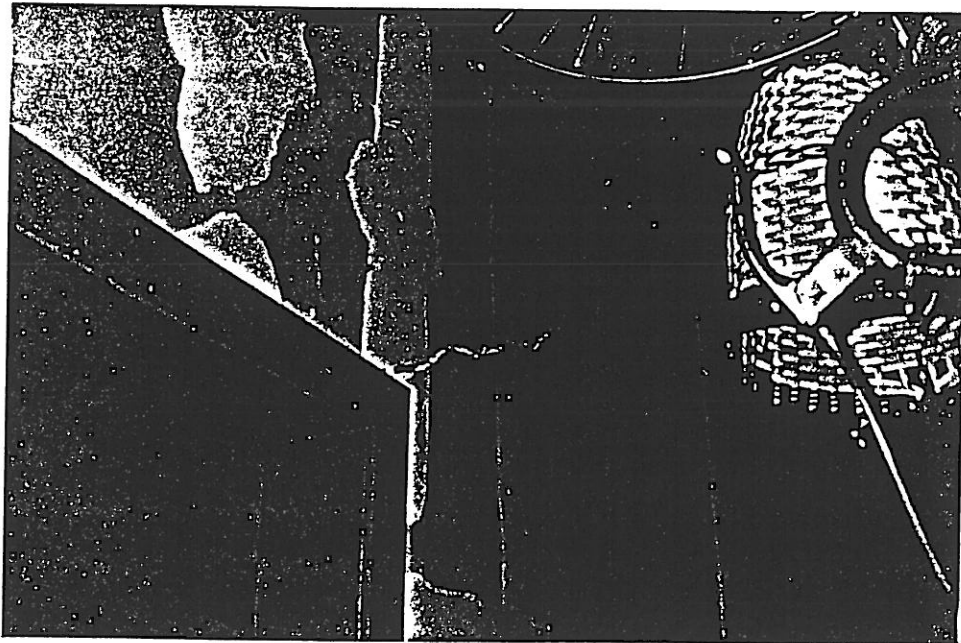
PHOTO #4: CRACK IN GARAGE WALL AT ENTRY TO FURNACE ROOM.
