PERMAFROST  
TECHNOLOGY  
FOUNDATION

FINAL REPORT

FOUNDATION STABILITY  
RESEARCH

1.5 MILE BALLAINE RD.

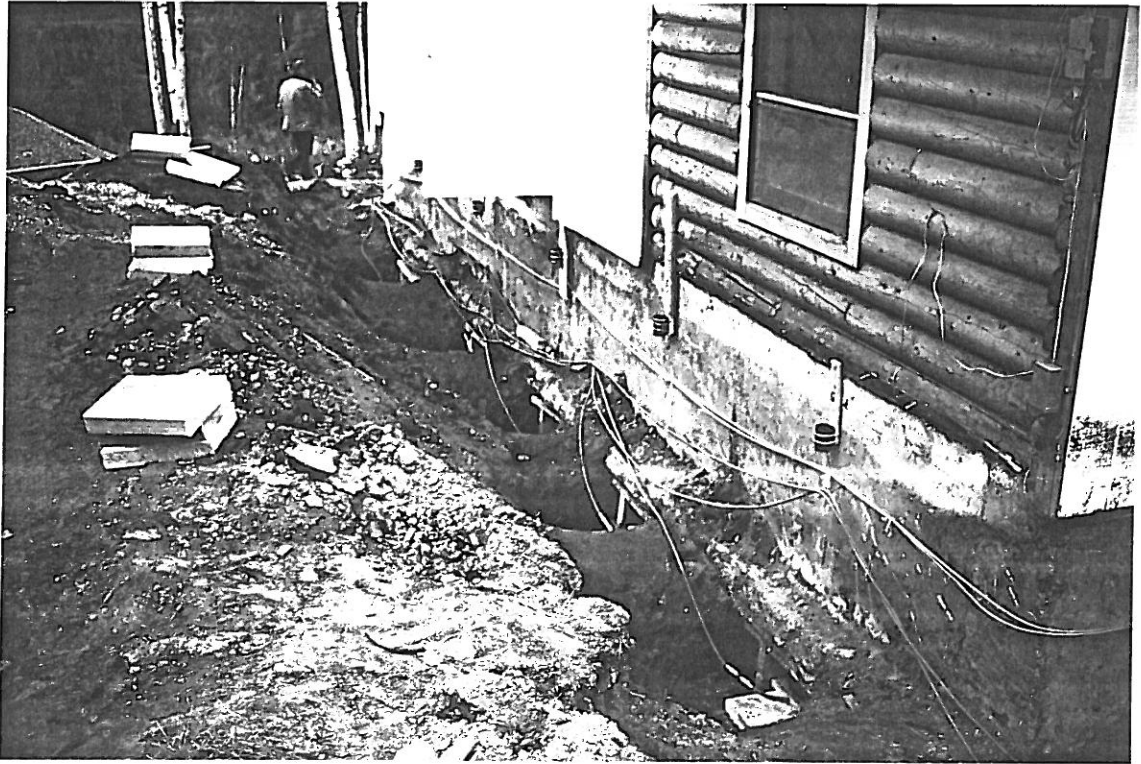
Figure 2c Pillow Jacks Installed Beneath the Footing

The initial action was to re-level the building to relieve stresses that accumulate from the wracking of the structure due to the uneven, differential settling taking place as the permafrost beneath the house thaws. The releveling process was accomplished by excavating around the outside of the foundation wall to expose the concrete footing. Small areas were then excavated beneath the footing to allow inflatable hydraulic pillow jacks (figures 2b & 2c) to be placed at numerous locations under the footing (approximately 15 jacks were used). The jacks were then carefully inflated with water using a small high pressure/low volume pump normally used for car washing. The pump, which was capable of supplying 500 psi, provided a slow, controlled raising and releveling of the building. This technique allowed the building to be releveled without incurring any structural damage due to over jacking at any one location. The hydraulic lines to the pillow jacks were all connected to a central control board where a valve for each jack could be switched on or off depending on the need (figure 2d). Water filled tubes were connected to a small cup reservoir attached to the foundation at each jack location. The "water level" tubes were also routed back to the central control board so that the level of the foundation at each of the jack points could be monitored at all times (figure 2d). In this manner, one person could control the lifting and releveling operation.

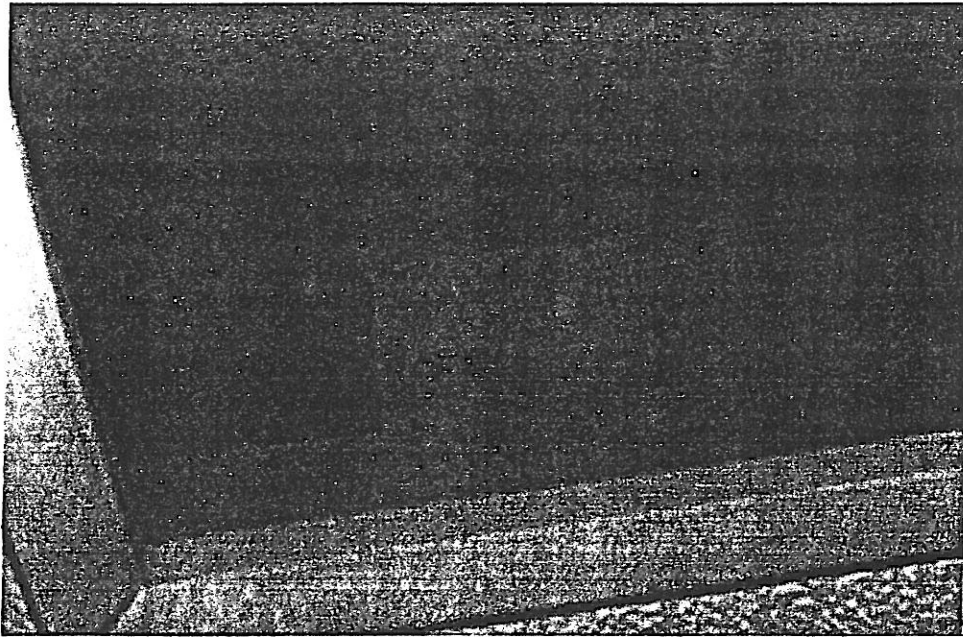
PHOTO #2: ROOF TRUSS GUSSETS INADEQUATELY  
CONNECTED (INSUFFICIENT NAILING).
