PERMAFROST
TECHNOLOGY
FOUNDATION

FINAL REPORT
ON
FOUNDATION STABILIZATION
USING A
HEAT PUMP COOLING SYSTEM
AT

728 CONSTITUTION ROAD

SEPTEMBER, 2000

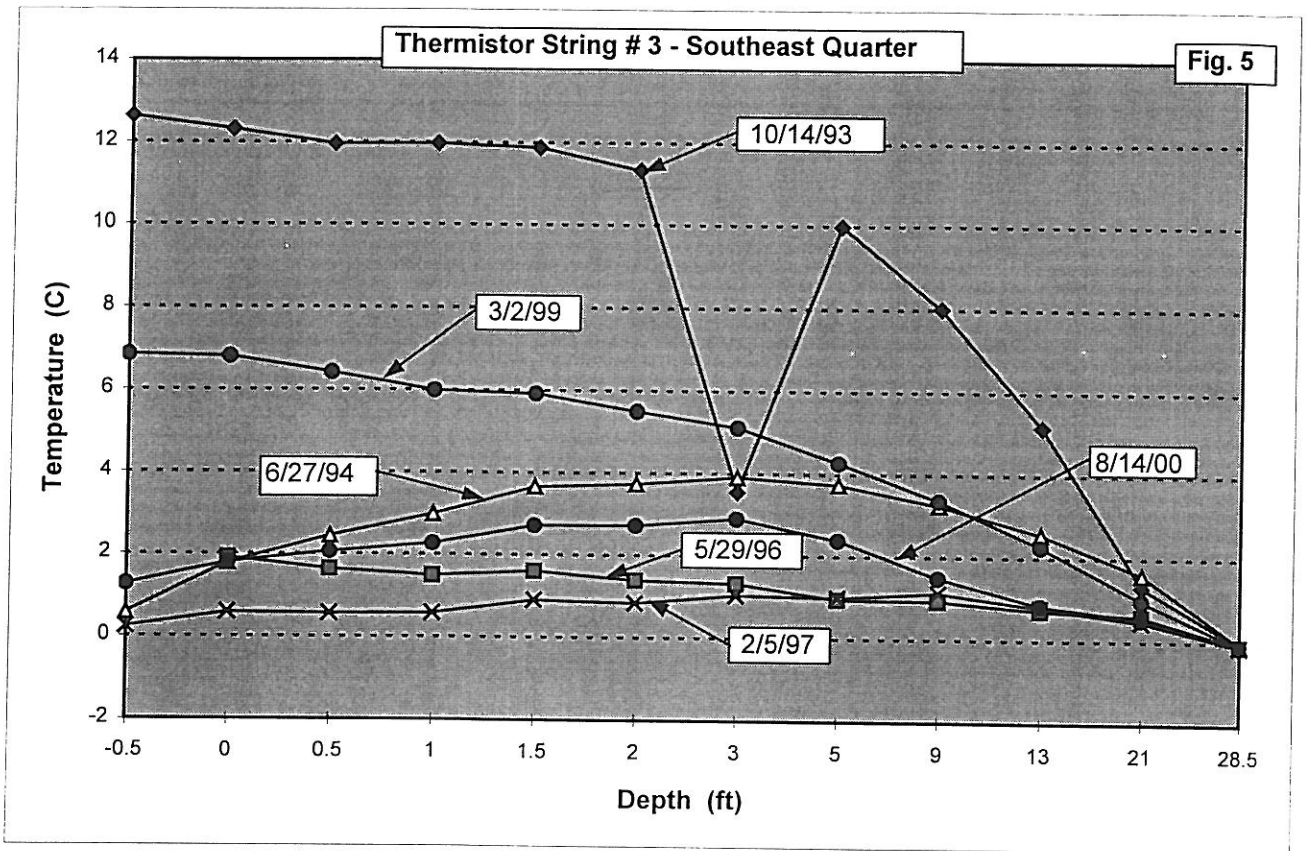
Figures 5 and 6 Temperatures vs Depth on Specific Dates

The temperature data shows that the heat pump system effectively removes heat from the soil beneath the house. Figures 5, 6, 7 & 8 show that the soil temperatures near the surface dropped by as much as 12°C (22°F) in the first eight months after the heat pump was activated in October of 1993 and continued to decline until the temperature at all levels was near 0°C (32°F) in February of 1997. With temperature trends clearly indicated, data collection was changed to a less frequent schedule in 1997 to reduce cost.

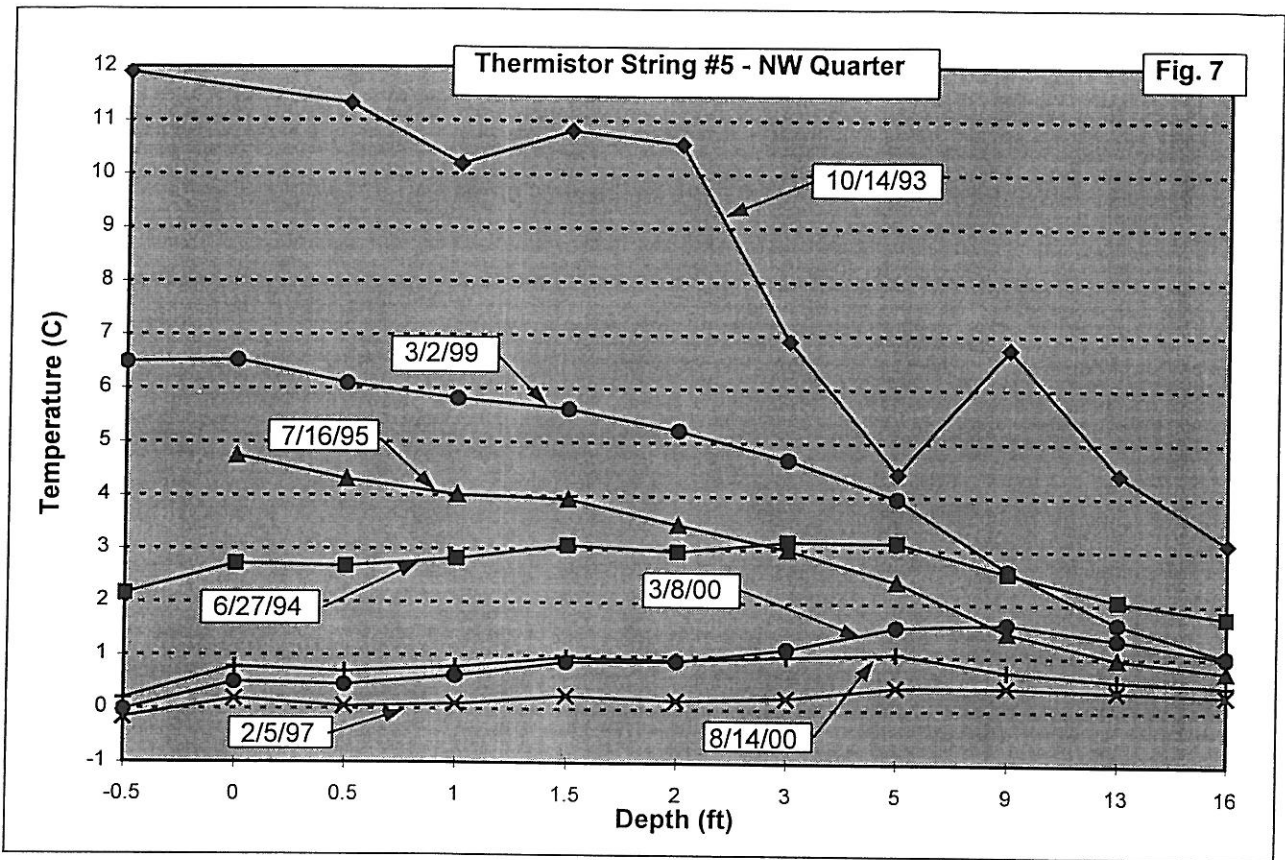
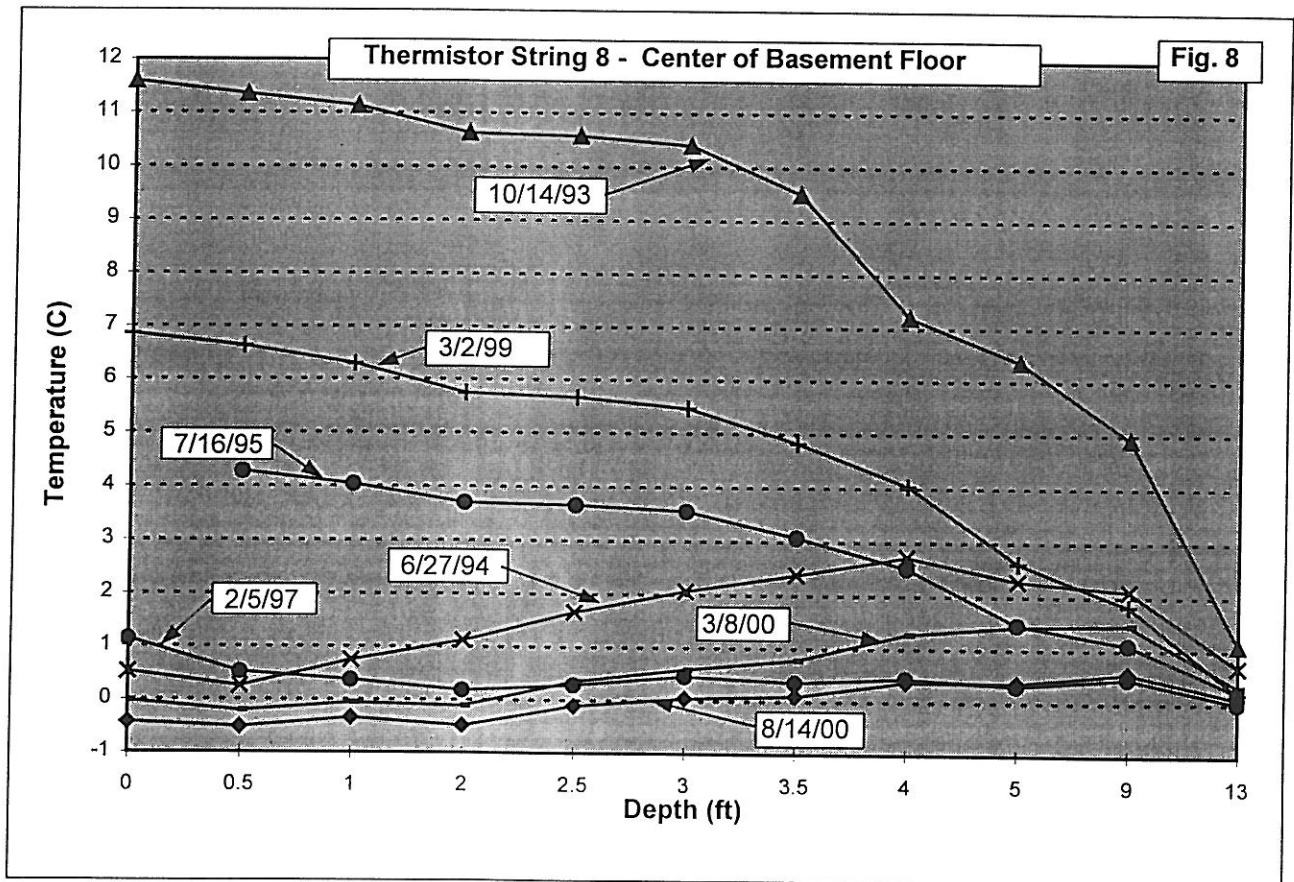
Figures 7 and 8 Soil Temperatures vs. Depth on Specific Dates

After the pump failure in early 1999, by March 1999, with no cold fluid circulating in the soil cooling grid, the soil temperatures rose by as much as 6°C (11°F) near the floor surface and by about 2°C (3.5°F) at and below the 24 ft depth. However, they were still substantially colder than the soil temperatures when the heat pump was first put into service in 1993 (figures 5 through 8). As the system removes heat from the soil, a cold soil mass is established that serves as a buffer to protect the permafrost for several weeks in cases of equipment failure such as this. Even with the second pump failure in, June 1999, allowing the system to be without cooling for over 5 months, soil temperatures on August 11, 1999 were still substantially below the 1994 temperatures as seen in figures 9 and 10. Once the circulation of the cold fluid was re-established the soil temperatures again dropped until by March 2000 they were approaching the pre-failure 1997 temperatures and by August 2000 they were even colder than 1997 under the center of the basement floor; as seen in thermistor string #8 (figures 7 through 10).

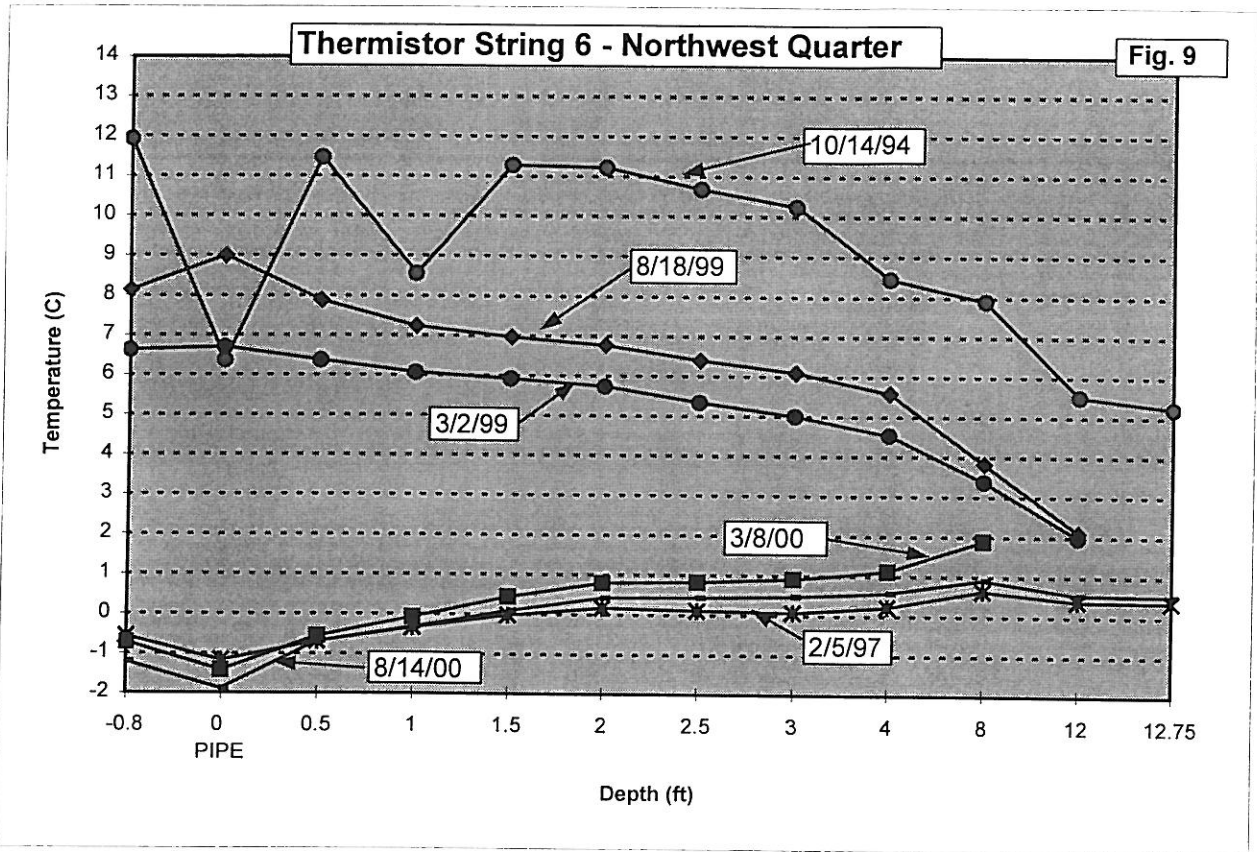
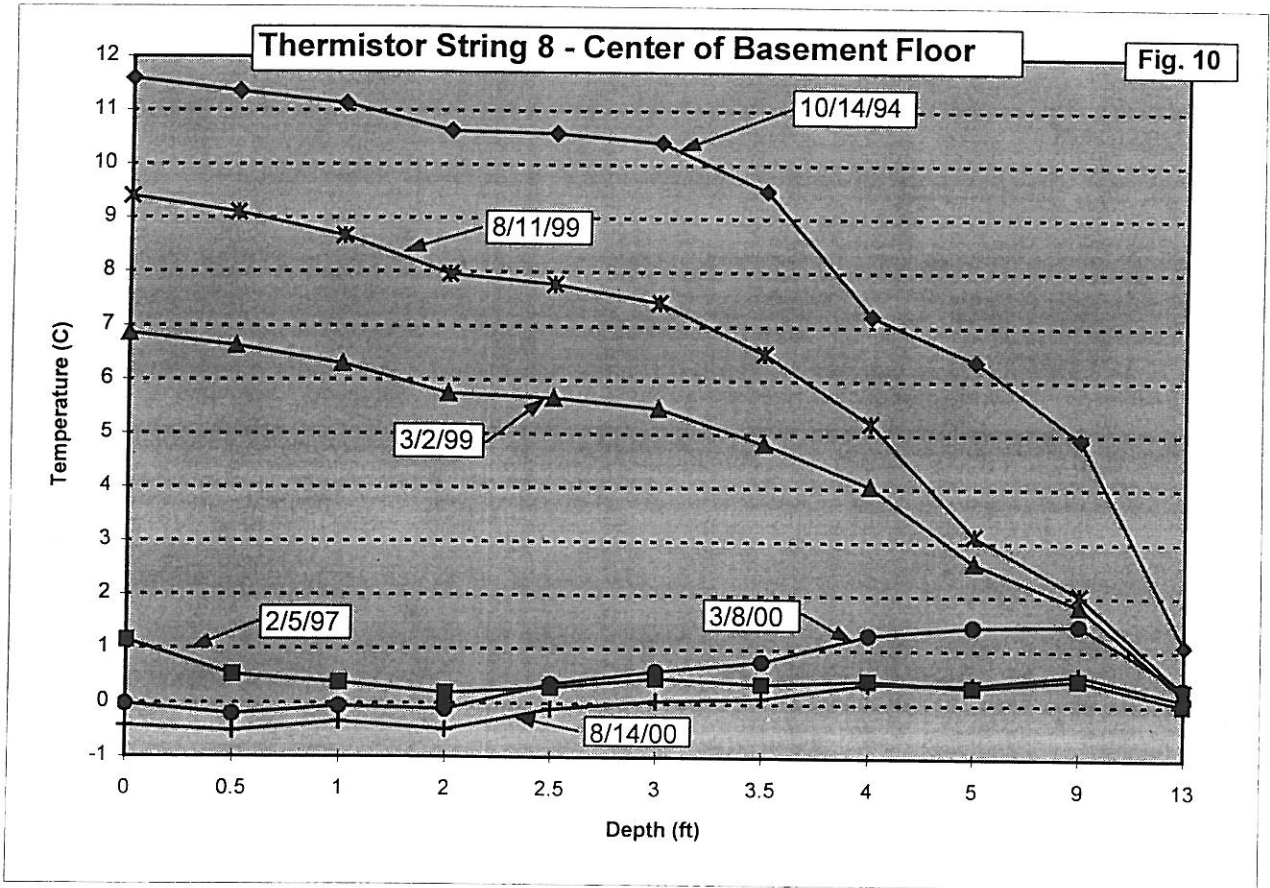
Figures 9 and 10 - Soil Temperatures vs. Depth for 2000, 1999, 1997 and 1994

The thermal inertia of the soil mass beneath the house can also be seen in figures 9 and 10. As discussed above, the pump that circulated fluid through the cooling-tube grid failed sometime in early 1999. Unfortunately, the exact time of the pump failure is unknown, however, the progress of soil warming can be seen in figures 9 and 10. The circulation of cold fluid to the cooling grid was finally re-established in early August 1999 and by that time temperatures had risen by 8°C (15.2°F) at the surface and nearly 1.5°C (2.5°F) at the 12 ft depth. In the five months between March and early August 1999 the progress of the warming was 2.5°C (4.5°F) near the surface and 0.07°C (0.13°F) at the 13 ft depth. This shows that the thermal inertia of the soil gave several weeks of protection to the permafrost even after active cooling had stopped. This provided a comfortable margin during which repairs were made even though a full scale shut down of the cooling system had occurred. The ability of the heat pump system to cool the soil

beneath the house is also shown in figures 9 and 10. Near the surface the soil temperatures rose by 8°C by the time of the second circulating pump replacement, but by March 2000 the temperature had dropped to below the 1997 value in the top layers below the cooling grid.

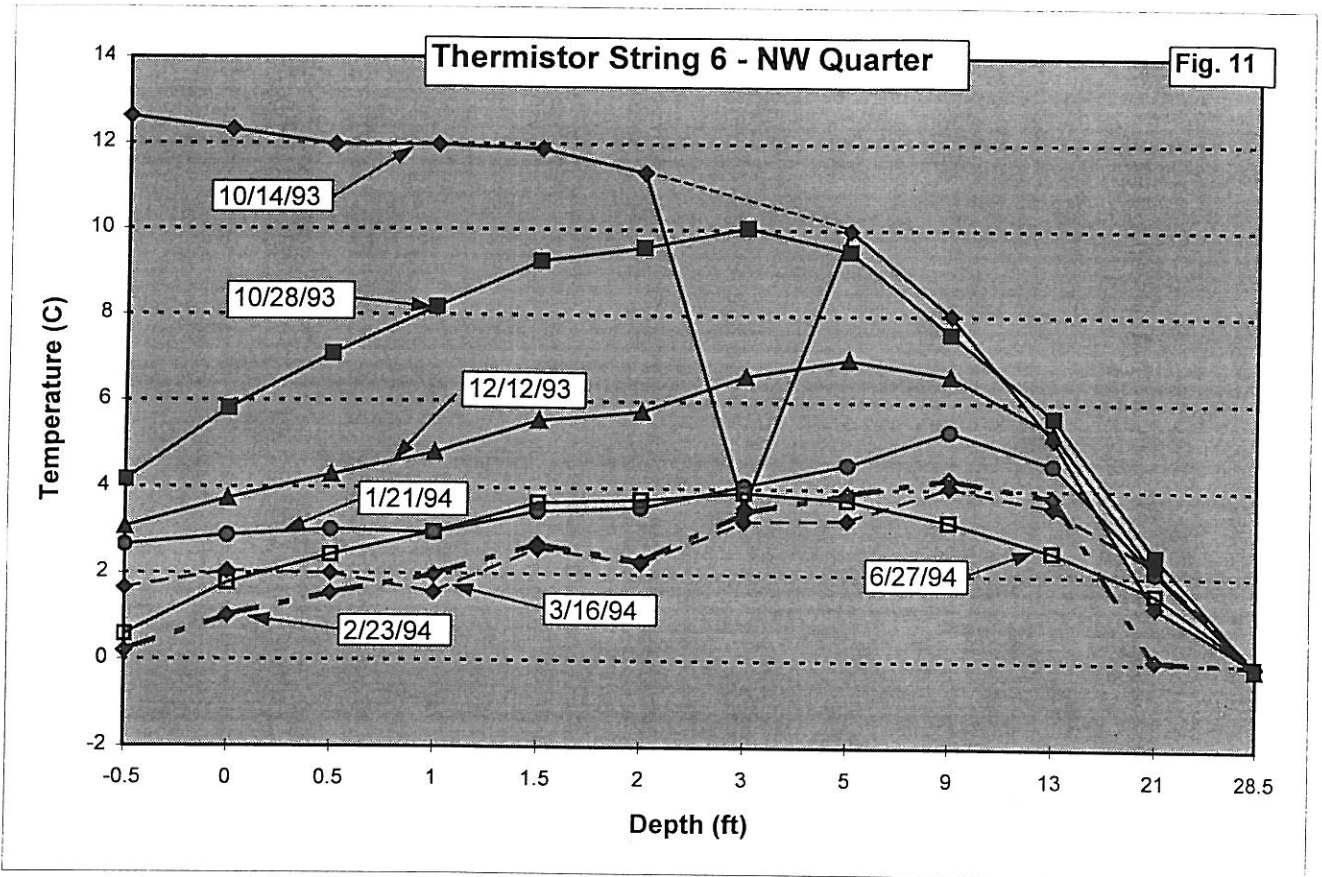
Figures 11 and 12 - Soil Temperatures vs Depth During the First Eight Months Operation of the Heat Pump

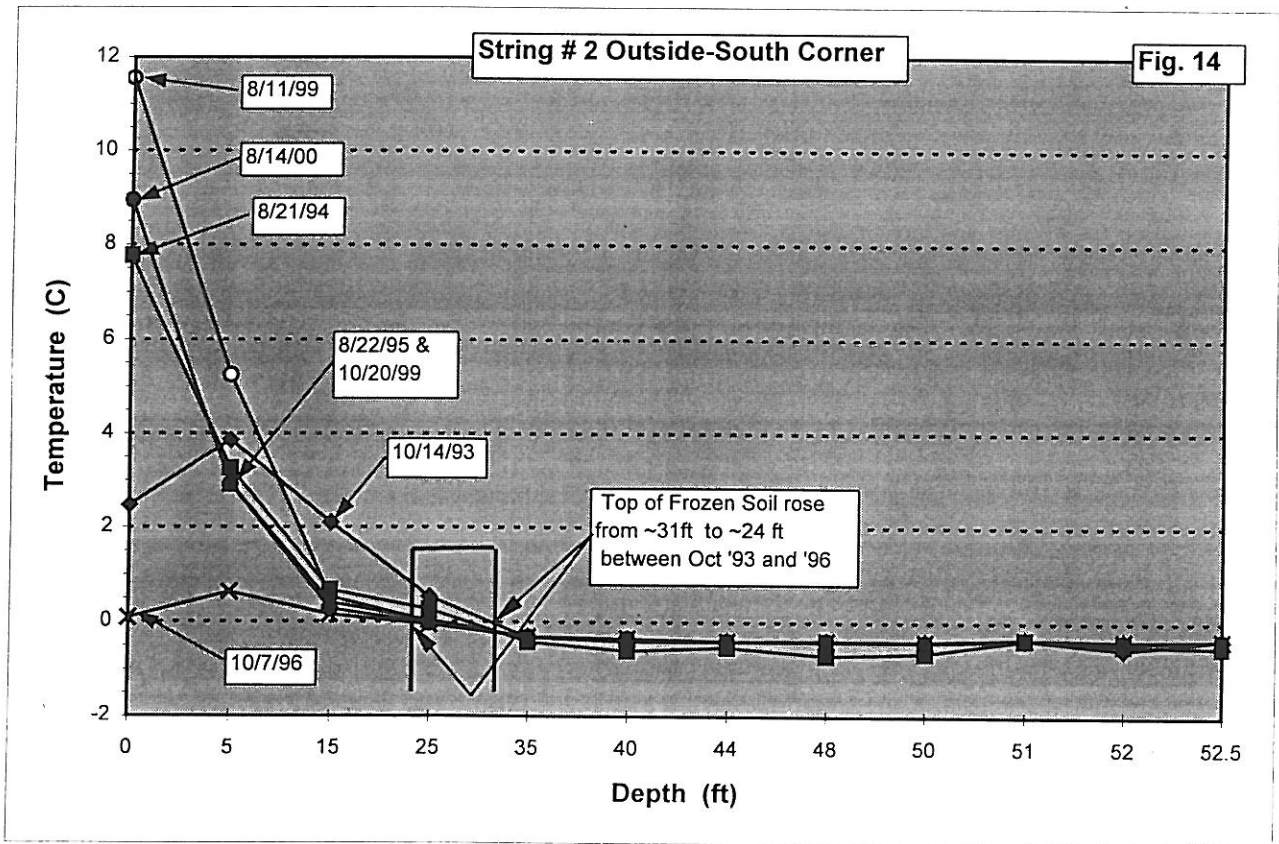
Figures 13 and 14 - Soil Temperature vs. Depth for Thermistor Strings 1 and 2 - Located Outside the House

One possible explanation for the floor level differential between point A and points D, J, L, M, S or AA in figures 15 - 17 could be frost heave of the soil at the surface just beneath the cooling-tube grid. Since frost heaving requires freezing soil temperatures, analysis of the soil temperatures during the time period in question is in order. Thermistor strings #3 through #8 measure temperature at various depth intervals down to as deep as 28 ft (string #3). Although these strings show an overall decline in the temperature of the soils at most depths, only very small changes in the height of the top of the permafrost are found (figures 19 through 24 show plots of the temperatures vs. depth for thermistor strings #3 through #8 at representative dates during the study). Note that thermistor strings 1 and 2 are outside the house and measure temperatures to a depth of 50+ ft in increments of several feet (figs. 13 and 14), whereas strings #3 through

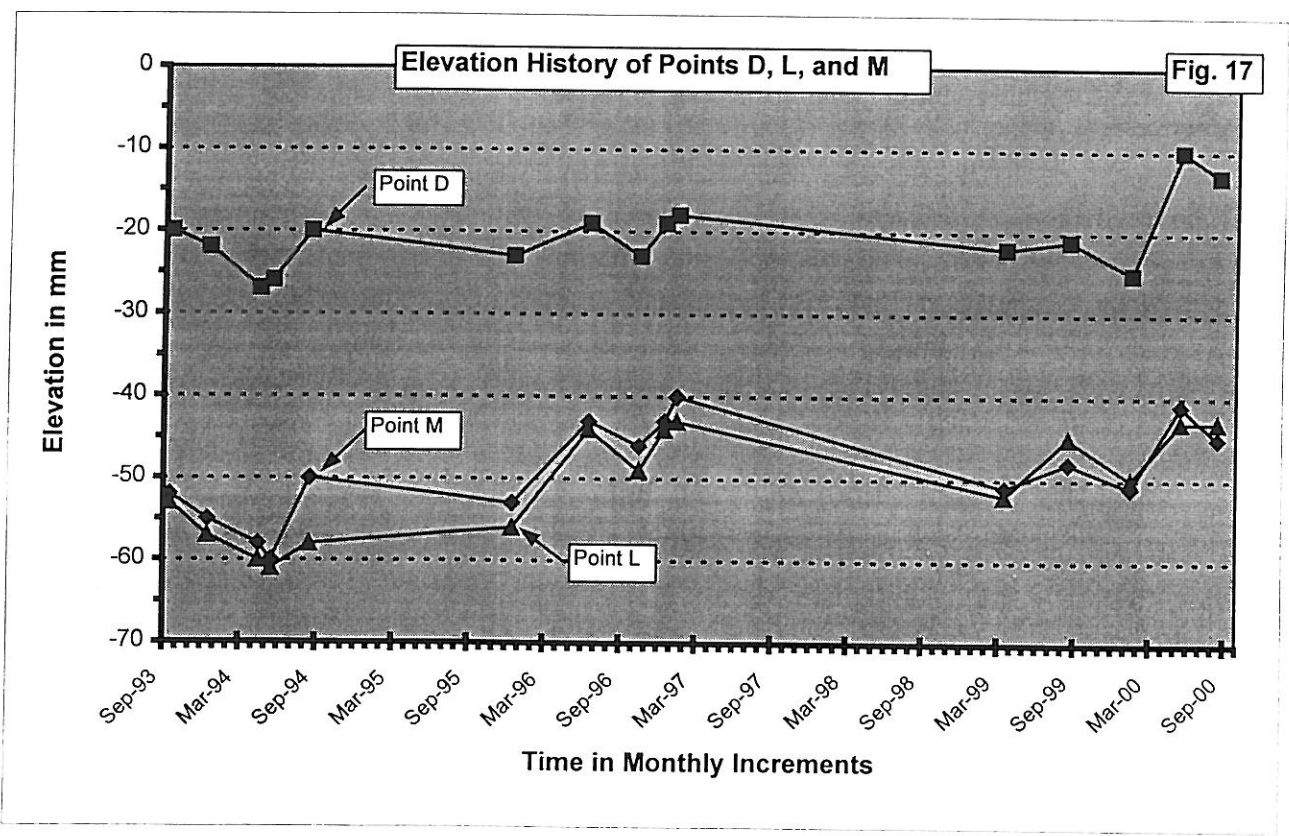
Figures 16 and 17 - Elevation of Selected Points on the Basement Floor with reference to Point A

Figures 16 and 17 show the history of the elevation changes of selected points on the floor from October 1993 to August 2000. One of the largest elevation changes occurs on the plywood floor in the southwest room (points S and AA). These indicate substantial heaving of the floor of approximately 55 mm (~2¼ inches) as seen in figure 16. However, the plywood floor floats on the insulation and the ground and it is not rigidly attached to the foundation. When walked across, the plywood floor could be described as "springy," thereby drawing into question the accuracy of points located on it since the weight of the data takers would deflect the floor yielding distorted elevation values.

Of more interest, therefore, are the points on the concrete floor strip and the concrete pad under the furnace. These points are more firmly associated with the foundation of the house and are considered more accurate. The elevation changes of these points are less than 10mm (~½ in.) over the measurement period (figure 17). In 6 years 10 months during which the levels were monitored, a change this small is nearly inconsequential. It may be enough to cause some minor hairline cracks in the wallboard (and some hairline cracks were noticed and repaired when the interior was painted in the summer of 2000) but little else. If the differential elevation change were to continue at this rate (½ in. every seven years) and not be corrected as was done at the beginning of the project (see section 2), the foundation might begin to show distress after about 40 to 45 years as the accumulated differential approached approximately 75mm (~ 3 inches). However, many homes will shift this much in 40 years due to material shrinkage, settlement etc. Note that with respect to the heaving of the plywood floor, most heaving occurred during the first half of the time period and little heaving is seen after March 1997. This suggests that if there were heaving under the plywood floor, it has now nearly stopped and the plywood floor may be reaching stability.

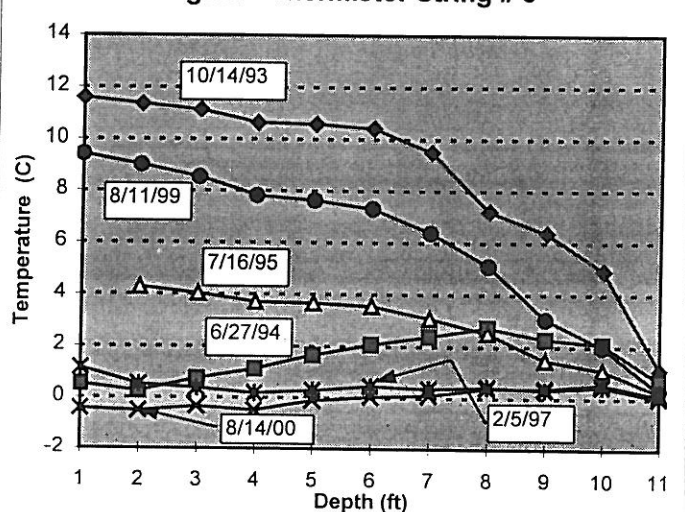
Figures 19 through 24 - Soil temperatures in the soil layers beneath the house

#8 are all inside the house and measure soil temperature beneath the floor at smaller, more frequent intervals but to much shallower depths (12 to 28 ft). String #9 measures the temperature of the cooling-grid fluid and air temperatures at various locations. Examining the temperature histories shown in figures 19 through 24, a frost heave scenario must be considered possible but it could be argued that it is unlikely since little increased frozen area is in evidence. However, strings #4 and #6 show a small amount of freezing at the surface and the temperatures at the deep end of each thermistor string are all declining, indicating that the bottom of the active thawed soil above the permafrost may be freezing (i.e. the permafrost is growing). If we concentrate on the temperatures near the bottom of the thawed soil above the permafrost, as is shown in figure 25, we see that string #2 shows that there is five feet of newly frozen soil at its location starting in early 1996 and lasting until the pump failure in 1999. This along with the moisture content noted in the drill logs certainly argues for the possibility of frost heave, at least in the small amount that has been measured. On the other hand, the amount of newly frozen material at the surface is small and disappeared during the circulating pump failure of 1999 without producing a corresponding, definitive reduction in the elevation differentials that indicate heaving (although points D, L, and M do show a small reduction in elevation difference in March of 1999 after the pump failure and a subsequent increase in March of 2000 after the pump had been reactivated for nearly nine months, see figure 17). So, although a plausible argument can be made for frost heaving, it can neither be conclusively ruled out nor confirmed. However, if frost heaving should ever cause problems in the future, several options are open to the owner.
