A Post-Conference Trip to the Transbaikalia Region

Following the TICOP conference Jim and Flo Rooney and Ray and Lee Ann Kreig traveled to the Transbaikalia region for an area tour. They also had the opportunity to visit and review a number of permafrost, frost heave, and major icing sites. The trip was initiated by a long-standing invitation from Valentin Kondratiev and was prompted by the early TICOP announcement of a post-conference Transbaikalia field trip that was subsequently dropped. Mr. Kondratiev then offered to honor a long-standing invitation that allowed the Rooney's to return to some of the areas visited in May, 1992 and it also provided a first time visit for the Kreigs. While we visited many very interesting places along our travels, this trip report is focused only on our opportunities to view and relate to common permafrost and associated technical issues.

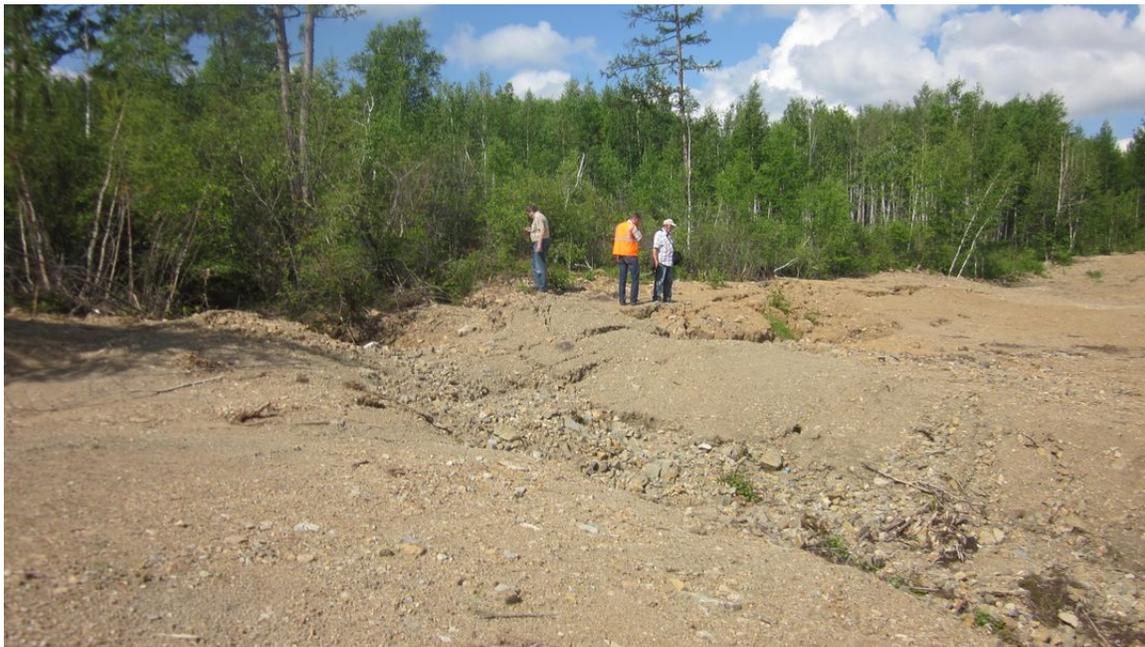
Photo 1. Trans Siberian Highway (Route 55). July, 2012 view of upslope area exhibiting frost boils and area of major winter icing conditions.

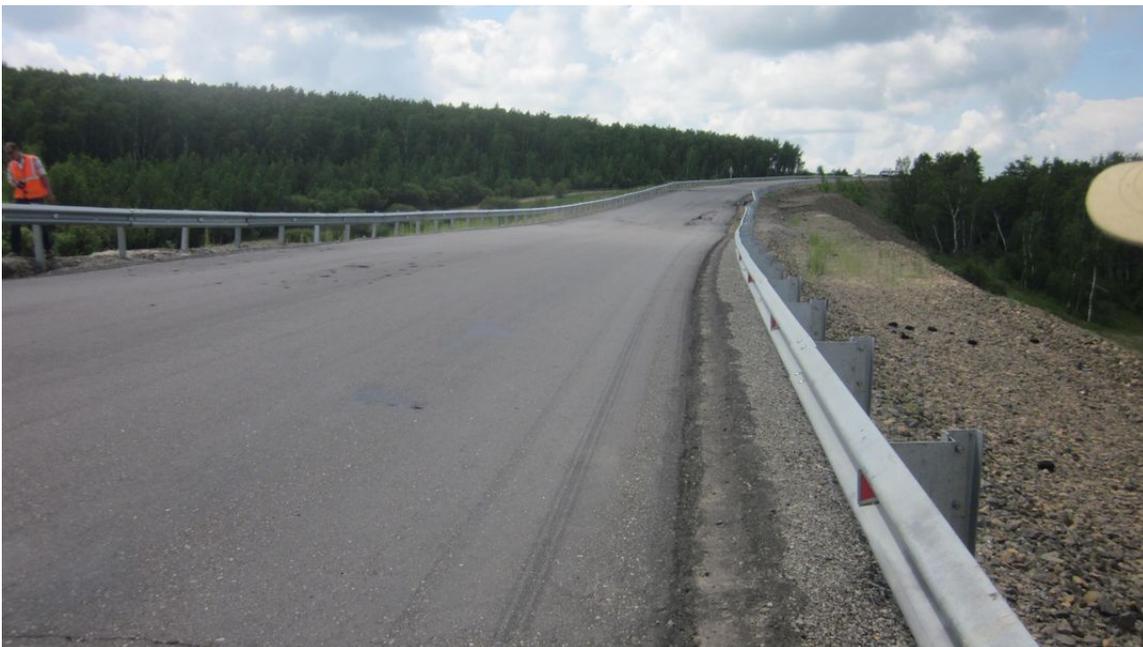
The following day allowed us to travel along the Trans Siberian Highway from the Chita origin point eastward for over 220 km. We were able to observe several points of technical interest that included; 1) a major side-hill cut area involving winter icing, 2) an upslope area of a recent development of frost boils exhibiting large exposed ice growth and causing roadway winter icing conditions (PHOTO 1), and 3) a major embankment failure that is continuing because of thawing of underlying permafrost degradation (PHOTO 2). The condition of this highway location has been addressed in prior papers by Kondratiev.

Photo 2. Trans Siberian Highway (Route 55). July, 2012 view of continuing major embankment failure resulting from underlying foundation permafrost degradation.

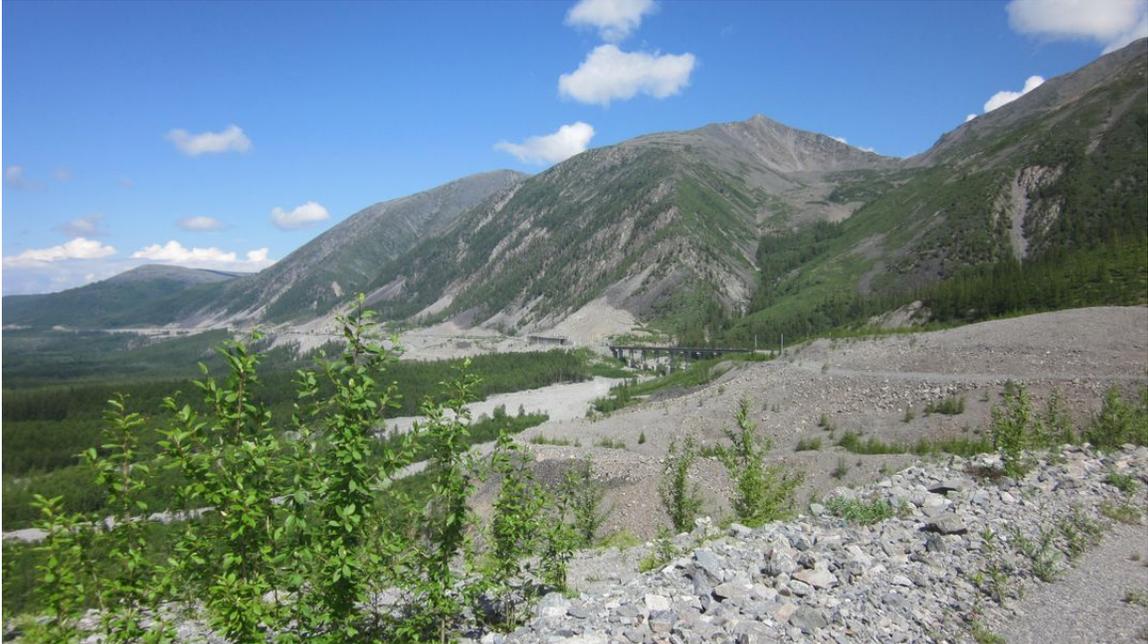
The trip then continued with a flight to Chara and the Chara Basin. This included a unique opportunity to review current conditions along the now abandoned Chara-Chena railway route to a proposed major mine development site (PHOTO 3).

Photo 3. July, 2012 view of abandoned Chena-Chara Railway ascending from the Chara Basin toward the Chena mine site. Project started in 1999 and shut down in 2002.

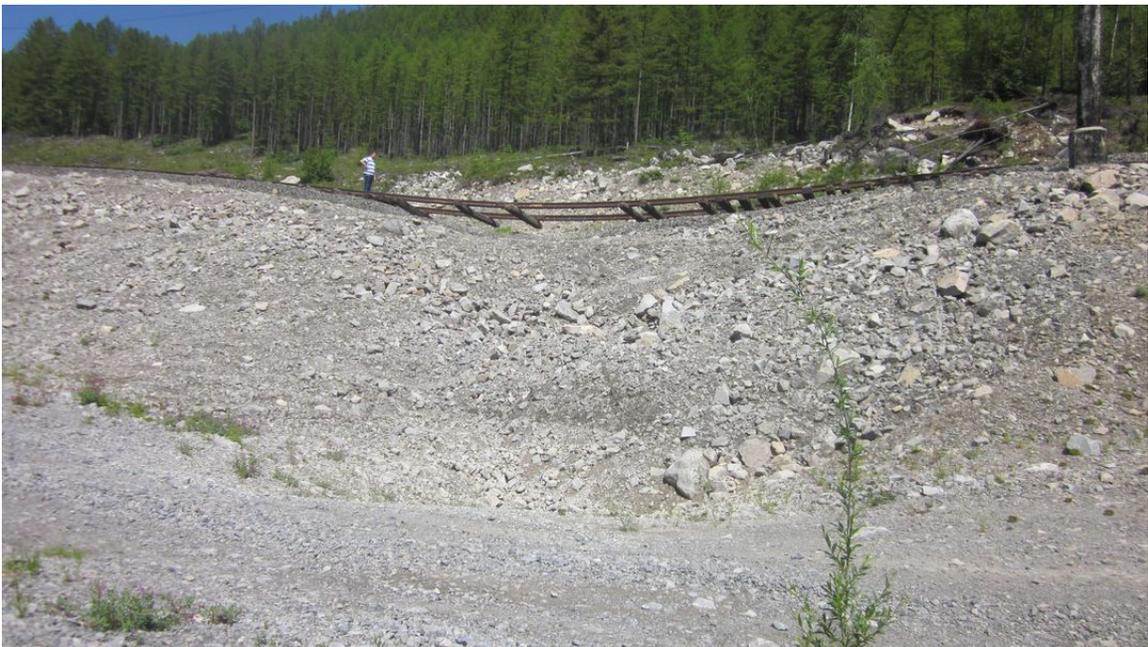
The partially constructed railway route was abandoned in 2002 and thus provided some special insights into permafrost related thawing ground subsidence since its closure. The route ascends from the Chara Basin upward into mountain terrain and traverses many natural and man-made obstacles. Some ground subsidence locations exposed hanging rail and ties at locations experiencing permafrost thawing (PHOTO 4).

Photo 4. Abandoned Chena-Chara Railway. July, 2012 view of segment exhibiting significant thaw settlement since closure in 2002.

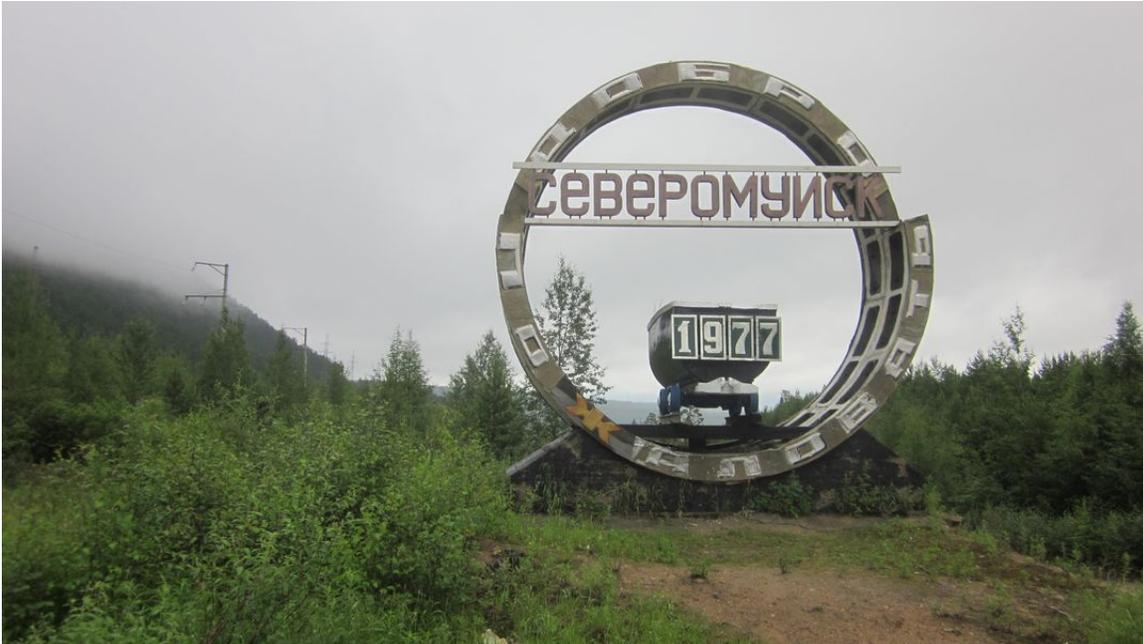
Photo 5. Baikal Amur Mainline (BAM) Railway. July, 2012 photo of monument commemorating the initial tunnel construction that began in 1977.

longer high pass route to a much shorter distance. The tunnel effort started in 1977 and, because of so many difficulties involving crossing large faults and major ground water impacts, was eventually completed in 2003 (PHOTOS 5&6).

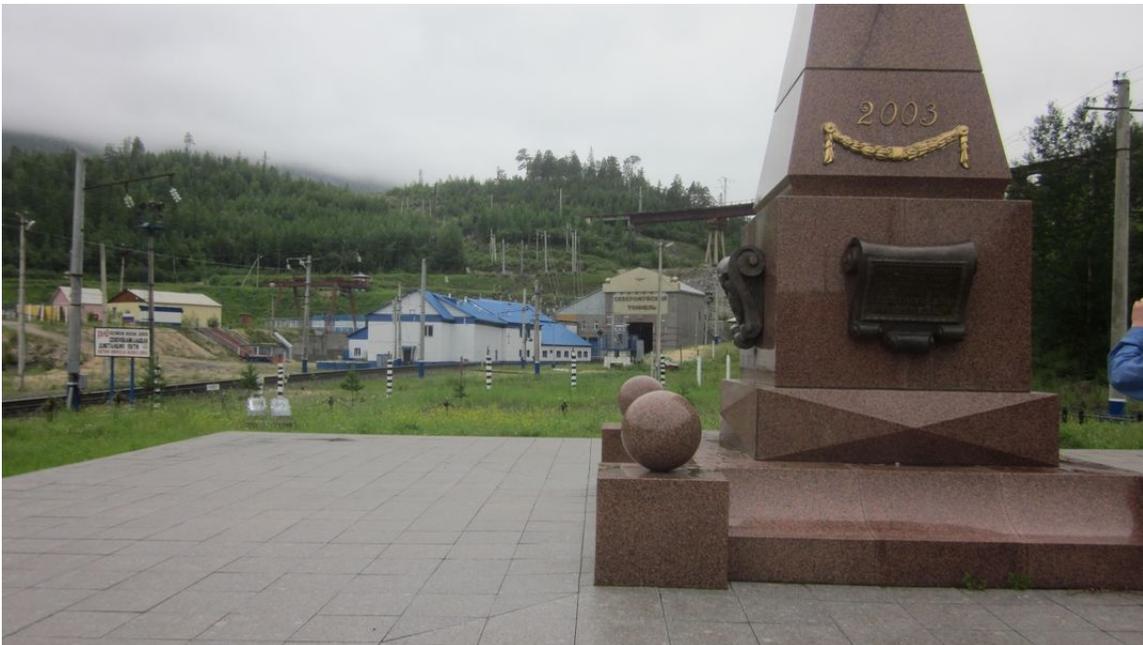
Photo 6. Baikal Amur Mainline (BAM) Railway. July, 2012 photo of the monument commemorating completion of the tunnel in 2003. Tunnel portal is visible behind and just left of the monument. This project encountered major ground water, fault systems and geothermal impacts on construction efforts.

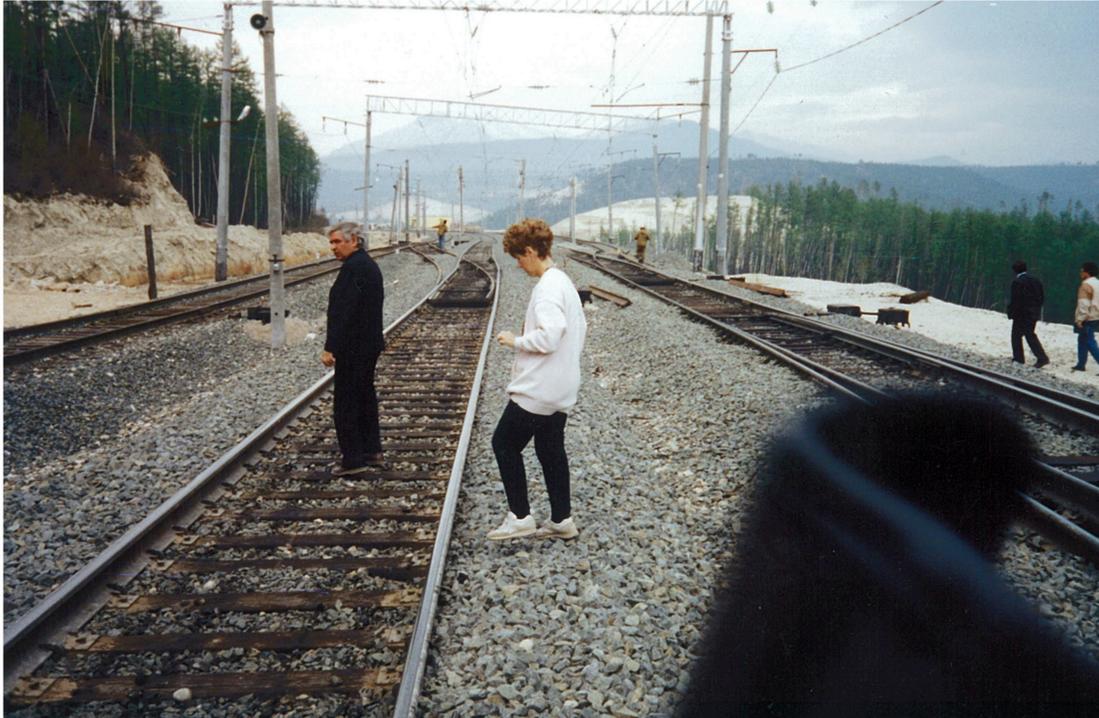
While in Severomuysk, we also were able to revisit an area with the most significant major thawing permafrost slope induced failure impact along the BAM railway system. The multi-track conditions during a site visit in June 1992 is shown in Photo 7. The initially planned multi-track short segment encompasses all of the most adverse impacts that can be encountered in frozen ground terrain and has now reduced the multi-track passage down to a single track with a 25 km/hr restricted passage (PHOTOS 8 & 9).

Photo 7. Baikal Amur Mainline (BAM) Railroad at Severomuysk. View of multi-track conditions during a site visit in June, 1992.

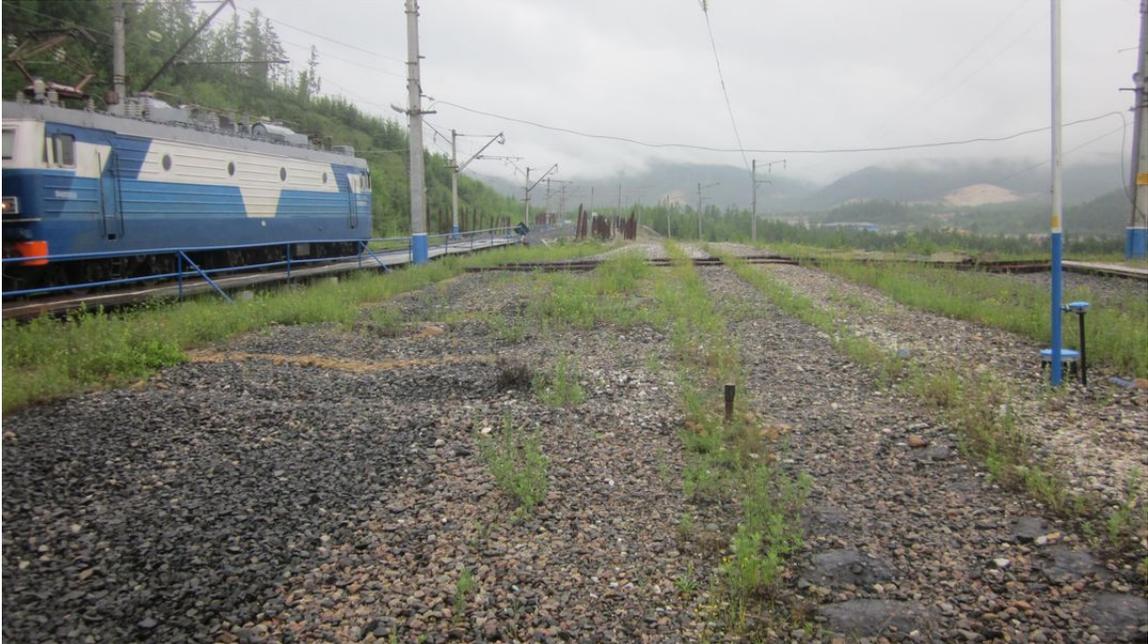
The failure conditions appear to involve both thawing permafrost as well as major subsurface and surface water flow that appear to be causing both subsidence and downslope movement. All prior applications of thermopiles, deep drainage infiltration interceptors, and more recently applied ACE rock treatments, appear to have had limited effectiveness.

Photo 8. Baikal Amur Mainline (BAM) Railway at Severomuysk. View of a very large continuing major slope instability area that has reduced travel through this segment to one track and maximum speed of 25 km/hr. Application of heat pipes, groundwater interception and recent air convection rock slopes has failed to stabilize this area.

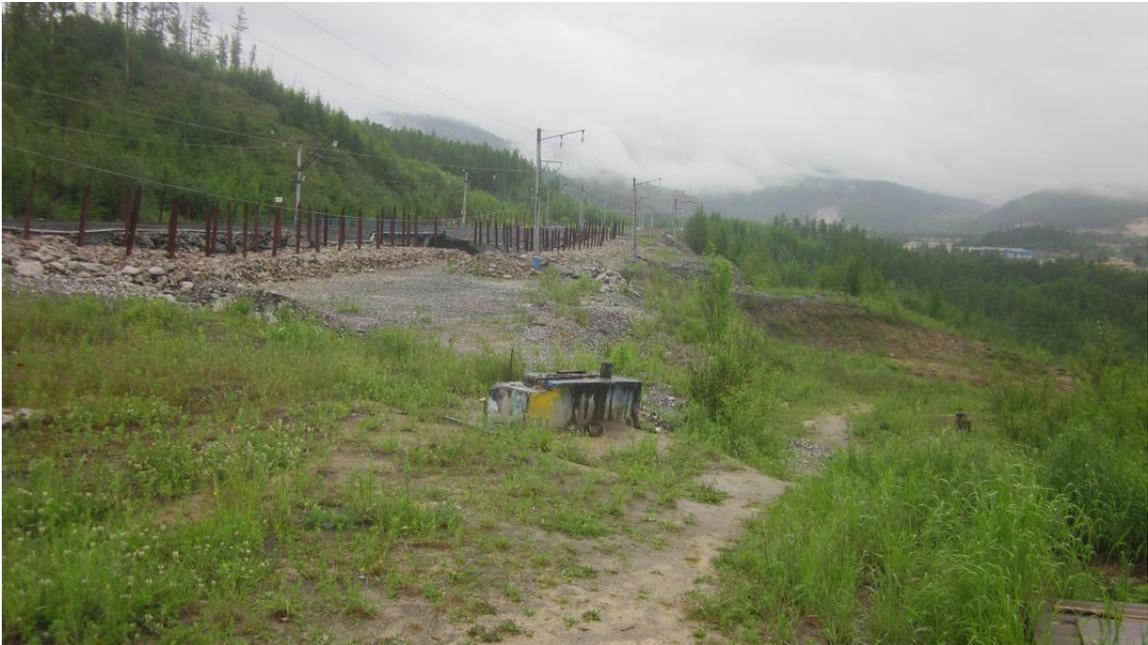
Photo 9. Baikal Amur Mainline (BAM) Railroad at Severomuysk. This original four-track station area now operates on a single line at reduced speed.

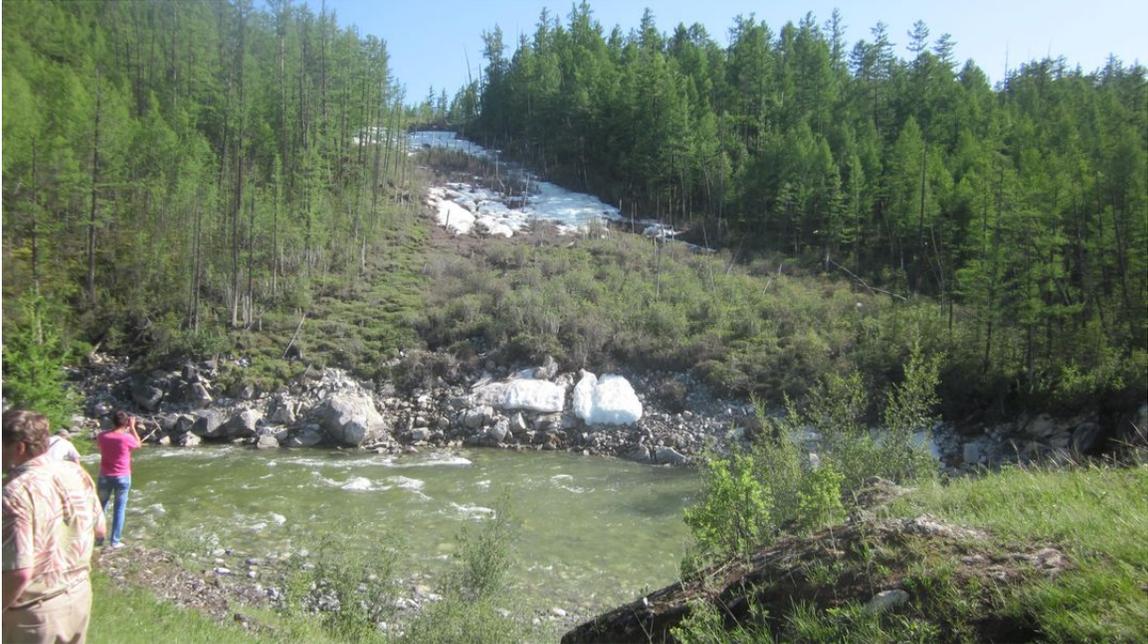
We then traveled to Ulan-Ude by air and had the occasion to meet the primary contractor involved with the Chara-Chena railway, as well as gain insights into his current business activities that now include both major horizontal and vertical construction. From Ulan-Ude, we traveled westward to Slyudyanka at the south end of Lake Baikal and further west into the Tunkinsky Valley along Highway Route A-164 for a stay in Arshan. We continued on the same route westward to the Mondy region, less than 5 km from the Mongolian border and only point of road access to the north end of Mongolian Lake Hovsgol Nuur. Aside from observing some roadway settlement resulting from apparent thawing permafrost, this area does have issues with winter icing events and we were taken to a site of a major icing (PHOTO 10).

Photo 10. View of remnants of a major icing area adjacent to Highway Route A-164 and the Irkutsk River in the Tunkinsky Valley. This icing condition was stated to have developed in very recent time.

We were told this condition had only begun to occur in recent years. An additional stop was made to view a large side-hill road cut into bedrock and glacial overburden. Slope raveling and sloughing was actively occurring and was requiring heavy maintenance and will involve a major remediation effort.
