PERMAFROST
TECHNOLOGY
FOUNDATION

FINAL REPORT

FOUNDATION STABILITY
RESEARCH

19 - 21 GLACIER AVENUE
FAIRBANKS, ALASKA

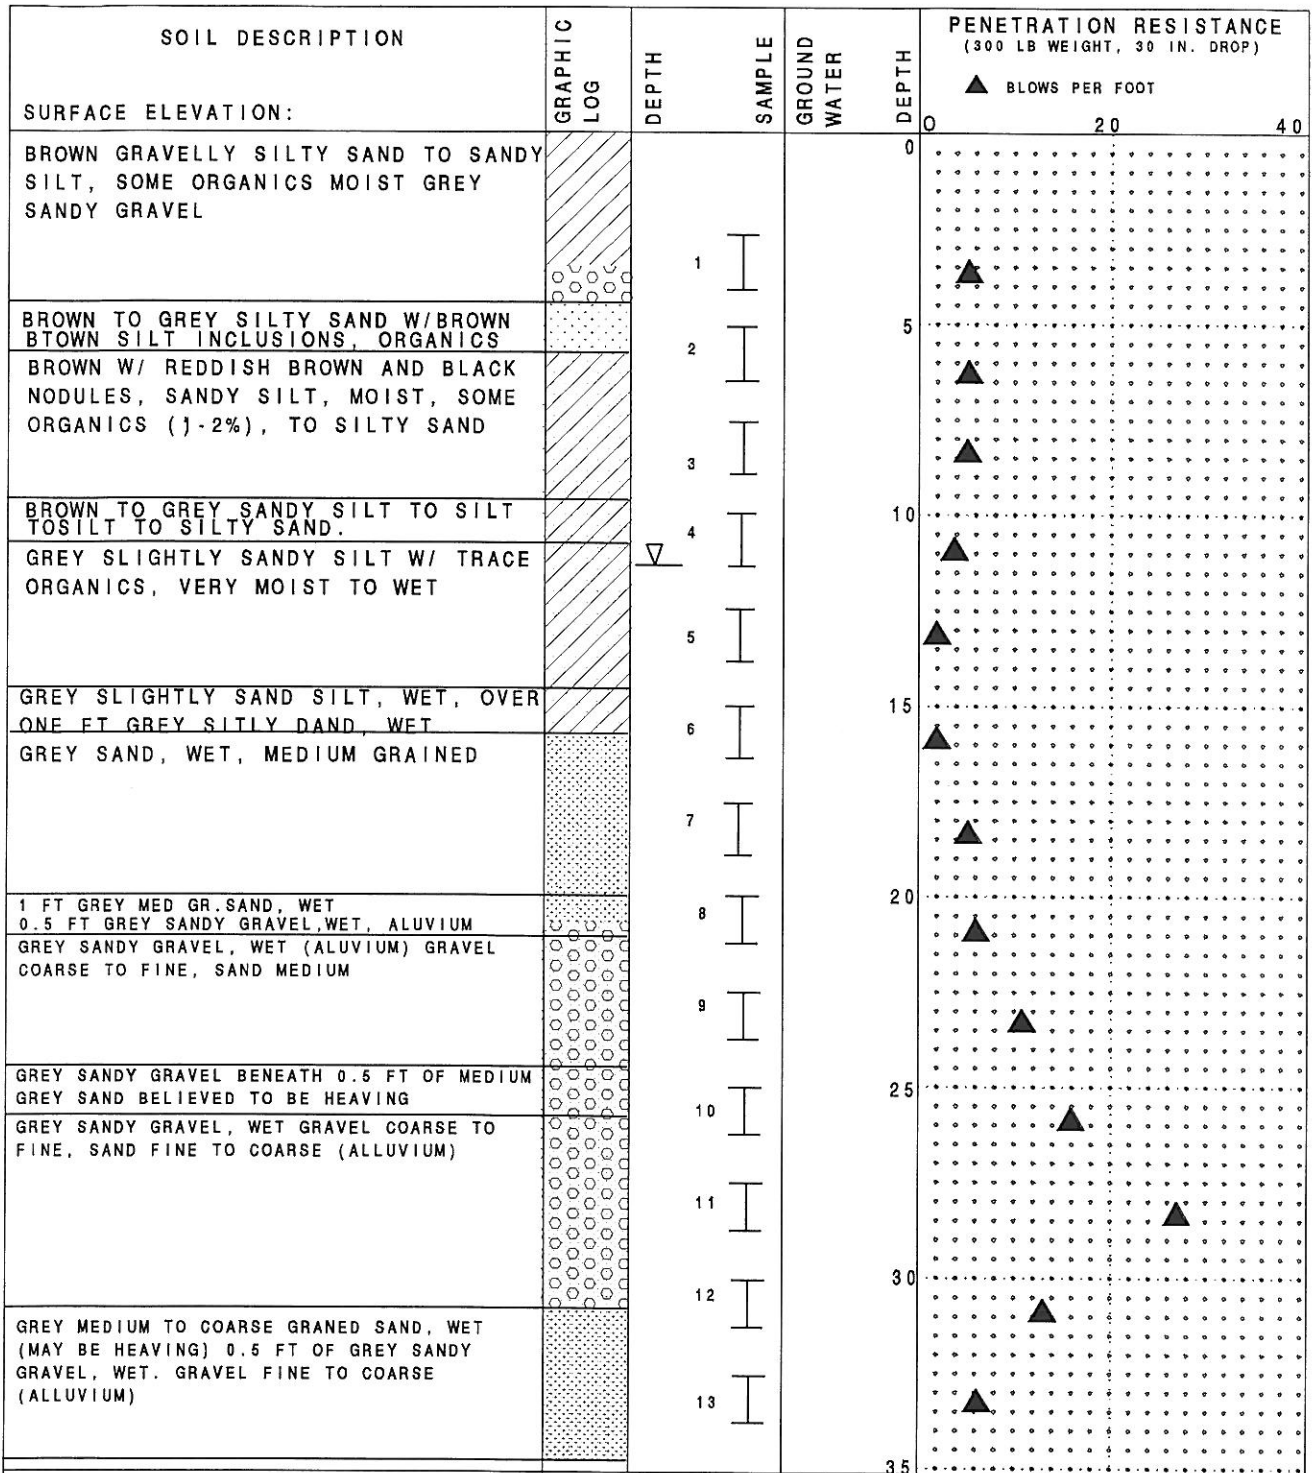
19-21 GLACIER ST.
BH1 SOUTHWEST CORNER
JULY 1, 1992

When PTF received the house, two additional borehole explorations were drilled, hole number 1 on the southwest corner 51.5 feet deep and hole number 2 on the northeast corner of the house 45 feet deep. Neither hole encountered any frozen ground, but both showed "heaving sands" at various depths. The driving resistance varied widely from very low at the 20 ft depth in hole 1 to high near the bottom of hole 2 (45 ft depth). Layers of loose sand as indicated by these drilling reports are subject to settlement, especially during dynamic events such as earthquakes, compaction during street repair etc. Based on this information, and the recommendations by Stutzmann Engineering, a search for a professional grouting service was initiated.

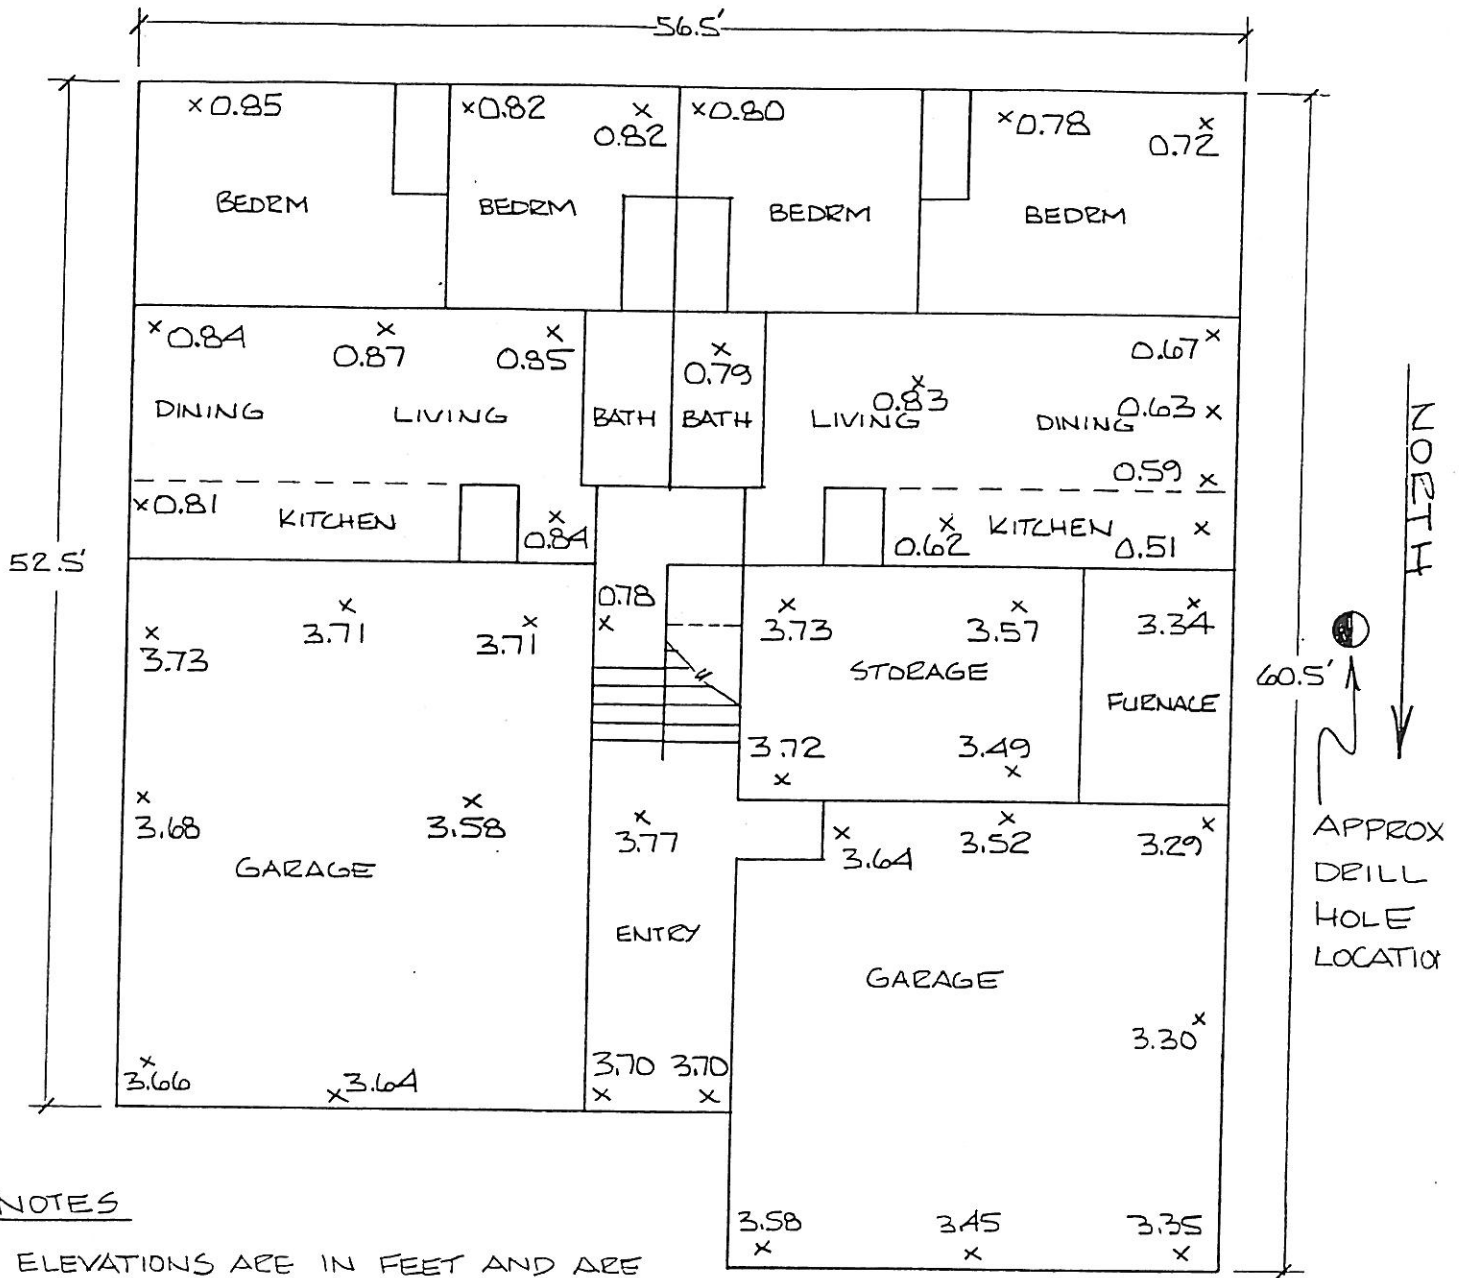
A.H.F.C #48739 19 GLACIER FIGURE 1

Because it was difficult to determine the nature of the movement, we measured relative floor elevations. Figures 1 and 2 indicate that, in general, the Westerly side of the building has settled as much as four or five inches relative to the Easterly side. This is based on the elevations found and the assumption that the building was initially constructed level.

We drilled our test hole near the West side of the building as shown in Figure 1. No permafrost was encountered. During drilling, we performed standard penetration tests at several depths to help quantify the strength of the soils beneath the structure. The test at fifteen (15) feet shows the silt to be extremely low strength. We believe the foundation settlement is a result of this loose, low strength soil consolidating under the load of the building. Our assessment is based on the assumption that the soils in the test hole are representative of those beneath the building.

LOWER LEVEL FLOOR ELEVATIONS

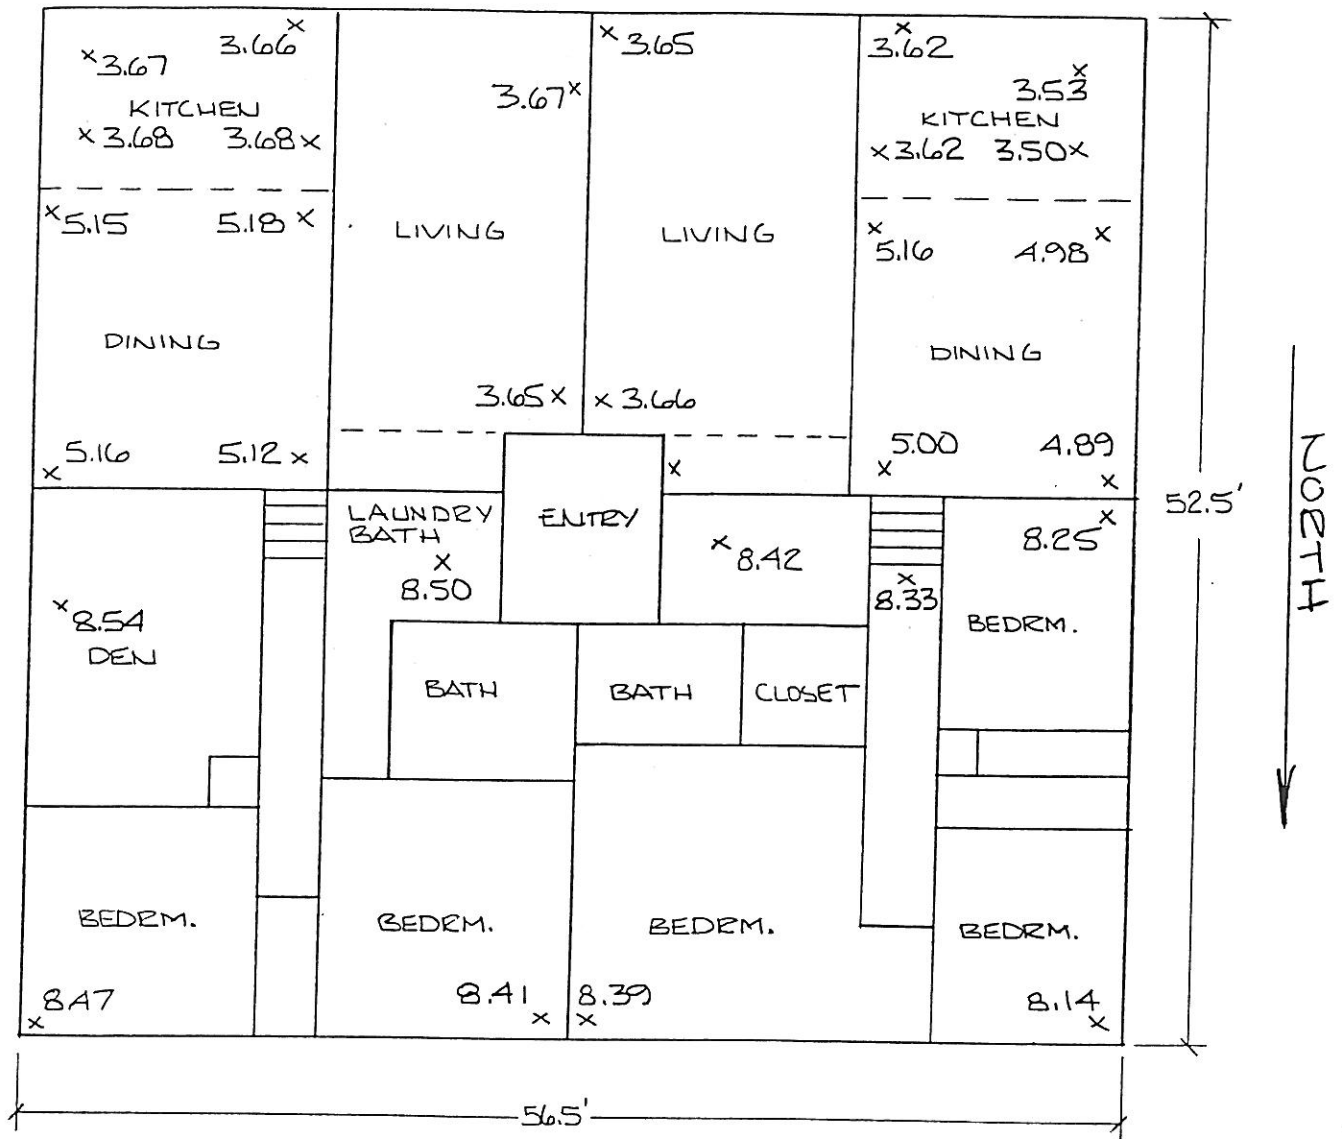
AHFC #48739 19 GLACIER FIGURE 2

The building is out of level (as indicated on the attached figures #2 and 3) by about 5" along the West wall.
